JOHN MIEDECKE  
AND  
PARTNERS PTY LTD

King Island Scheelite

REHABILITATION PLAN

July 1991

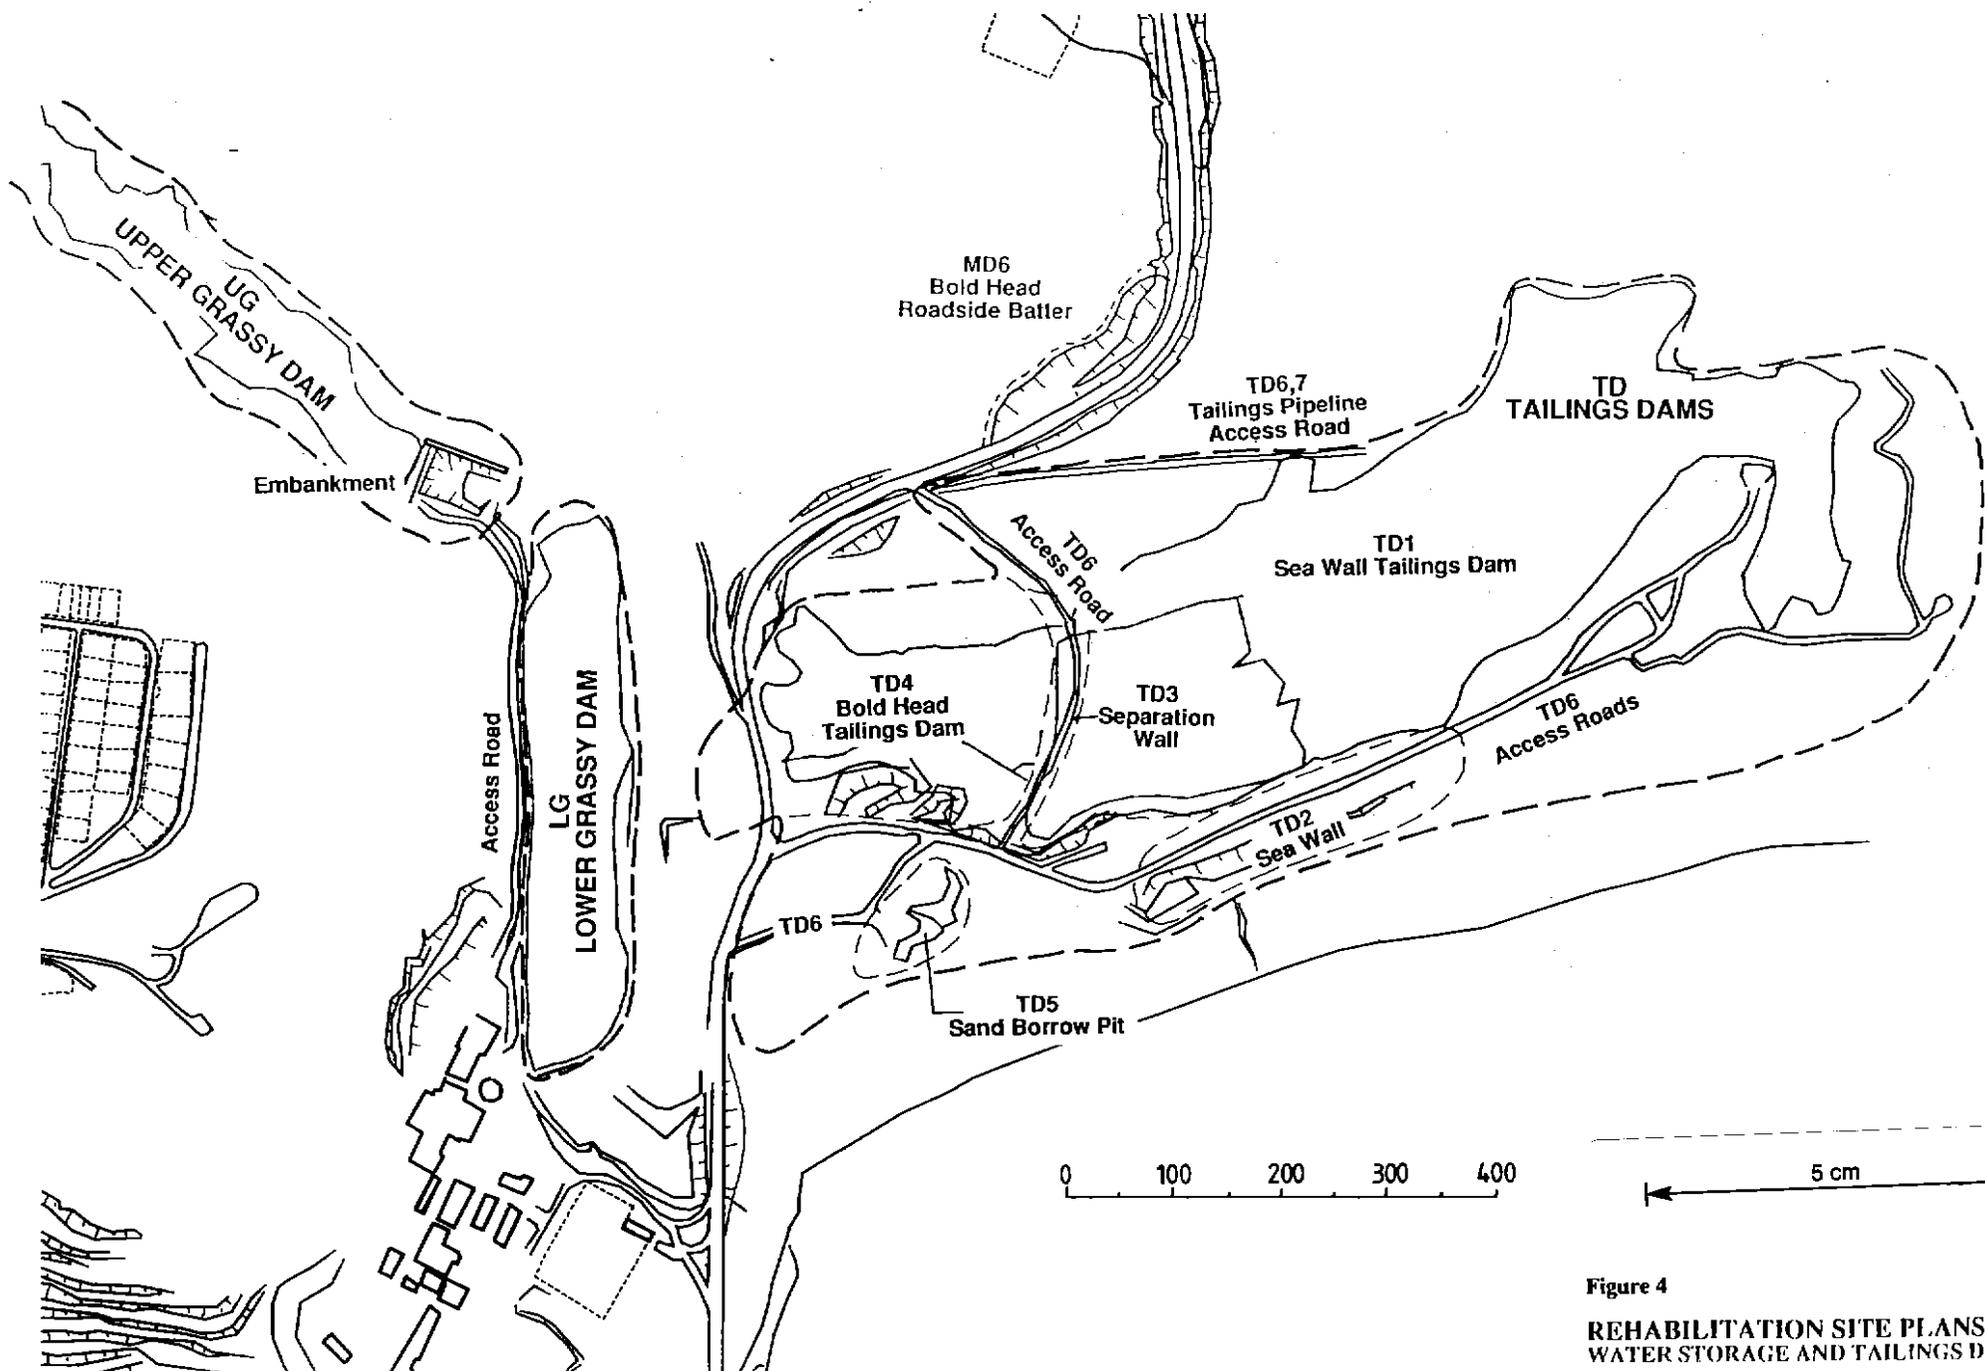
Figure 4

REHABILITATION SITE PLANS  
WATER STORAGE AND TAILINGS DAMS

### 5.3.8 UPPER GRASSY DAM UG (Figure 4)

### **5.3.9 LOWER GRASSY DAM LG (Figure 4)**

### **5.3.10 TAILINGS DAMS TD 1-7 (Figure 4)**

There are two tailings dams in the lease area. They are the Bold Head Road tailings storage which adjoins the Bold Head Road and the Seawall Tailings storage which has been constructed near the coastline Plate 5.6 shows the tailings storage surface. The latter contains the majority of the residue from the processing operations. The storages are shown in Figure 4. Access to the dams is via the main access road and the foreshore road between the Mill and the coastline. Also associated with the tailings dams are the access roads, tailings pipelines and the sand borrow pit (see Figure 4).

#### **5.3.17.6 Bold Head Cut MD6 (Figure 4)**

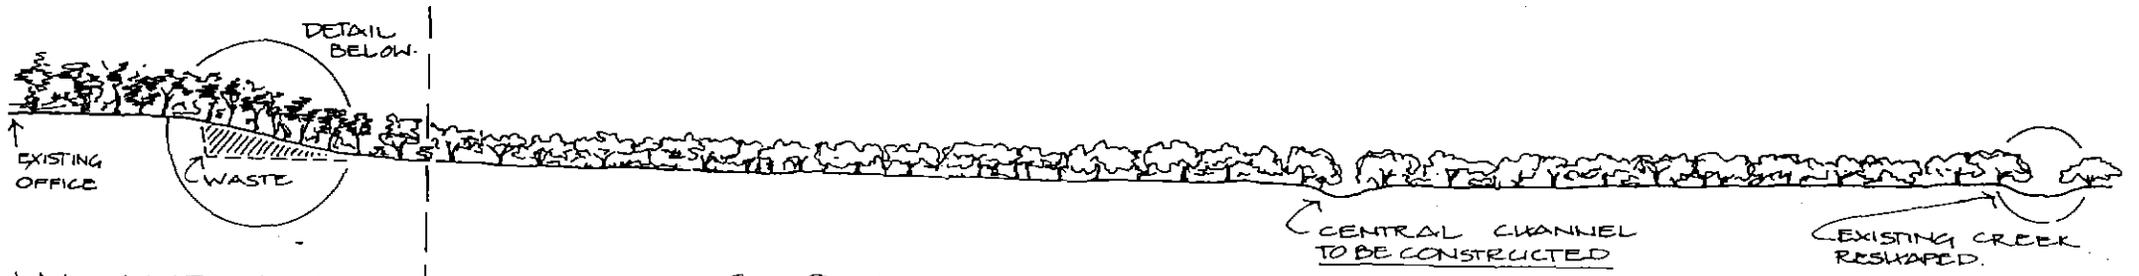
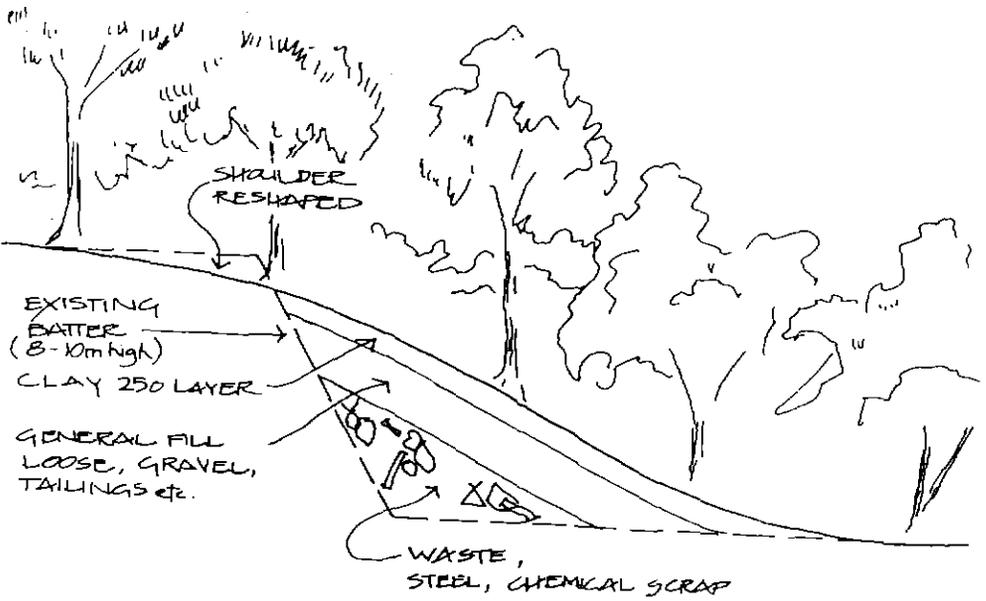
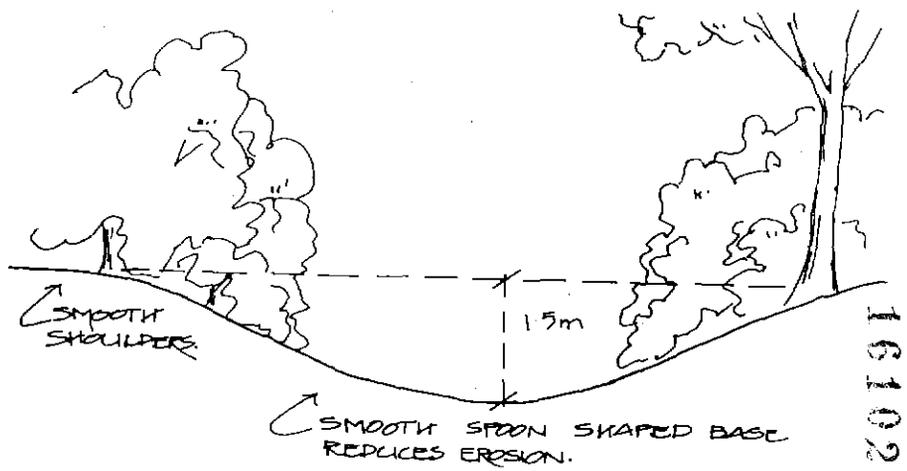
**Figure 7A**  
**MILL AREA - LANDSCAPE PLAN**  
 North - South Section

**INLAND MIX**  
 Gradually rises from 5-10m and changes character from a coastal scrub to forest.

CHANGE OF SEED MIX ROUGHLY CORRESPONDS TO BASE OF PROFILED BANK.

S/SE ..... **INDICATIVE SECTION** ..... N/NW  
 APPROXIMATELY 1:1000

**SECTION TYPICAL RESHAPED BATTER**  
 EX. OFFICES AREA  
 NOT TO SCALE

**SECTION**  
 - RESHAPED CREEK  
 =  
 - CENTRAL CHANNEL TO BE CONSTRUCTED  
 Not to scale

The latter are likely to include the concrete sections of the coarse ore bin, the primary and tertiary crusher, fine ore bin and the mill and artificial scheelite building foundations. The method and final treatment of these foundations can only be addressed after the buildings have been removed and the foundations exposed. A conceptual landscaping plan is shown in Figures 7A and 7B.

Other areas including the fill batters and settling dams will be profiled and contoured in accordance with the landscape plan (Figures 7A and 7B). Unsuitable materials will be covered with clay, and compacted areas ripped.

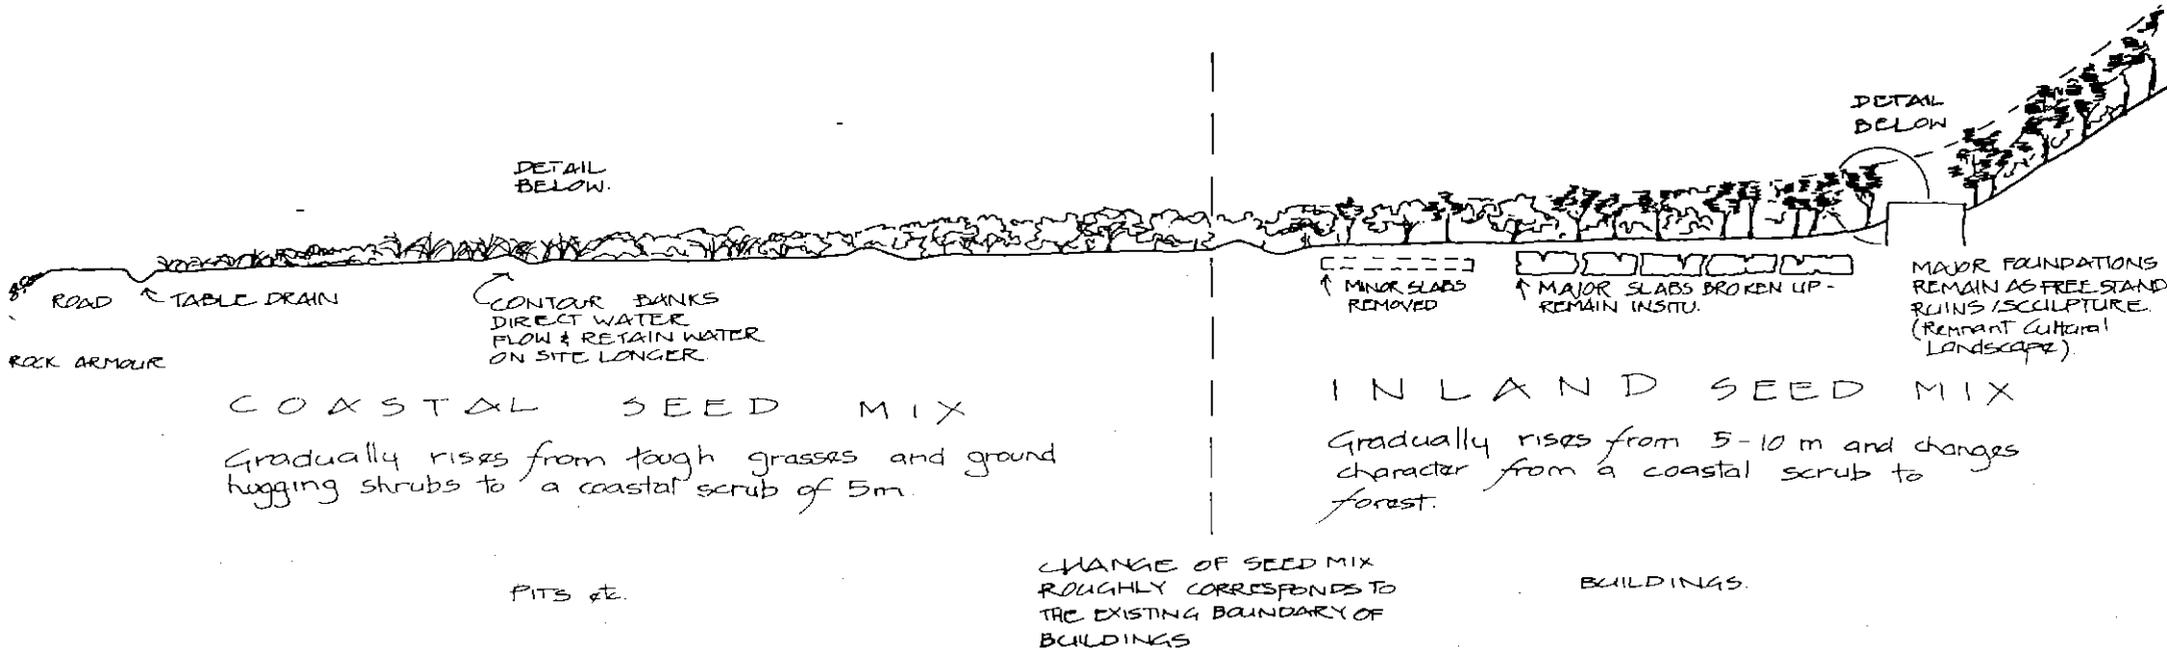
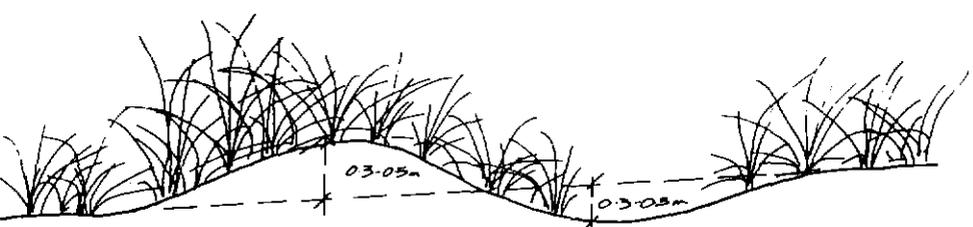
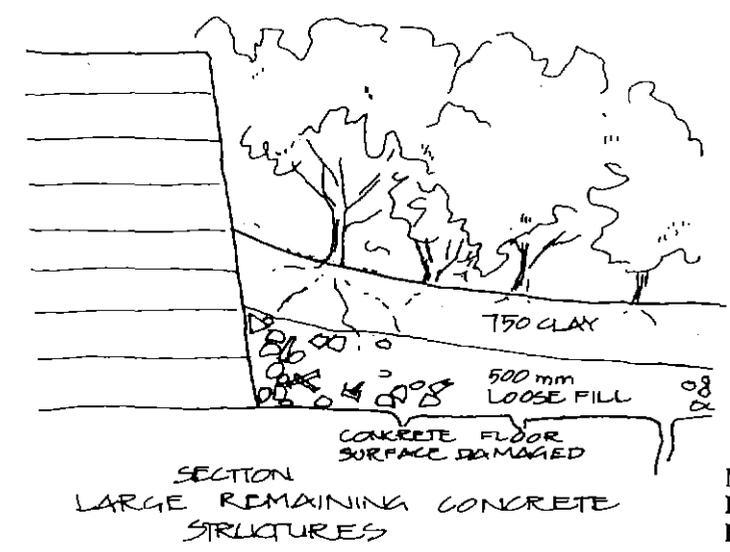
Figure 7B  
 MILL AREA -  
 LANDSCAPE PLAN  
 East- West Section

E/NE . . . . . INDICATIVE SECTION . . . . . W/SW  
 APPROX 1:1000

CONTOUR BANKS SECTION.

NOTE Water flows along contour banks at gentle grade 1-3% At NO point should wall of contour bank be level or lower than any point in the drainage swale, as this can result in a breach.

The banks and bottom will be profiled and an overflow diversion channel constructed to direct river flows to an alternative discharge point. This is shown in Figure 7B and 8.

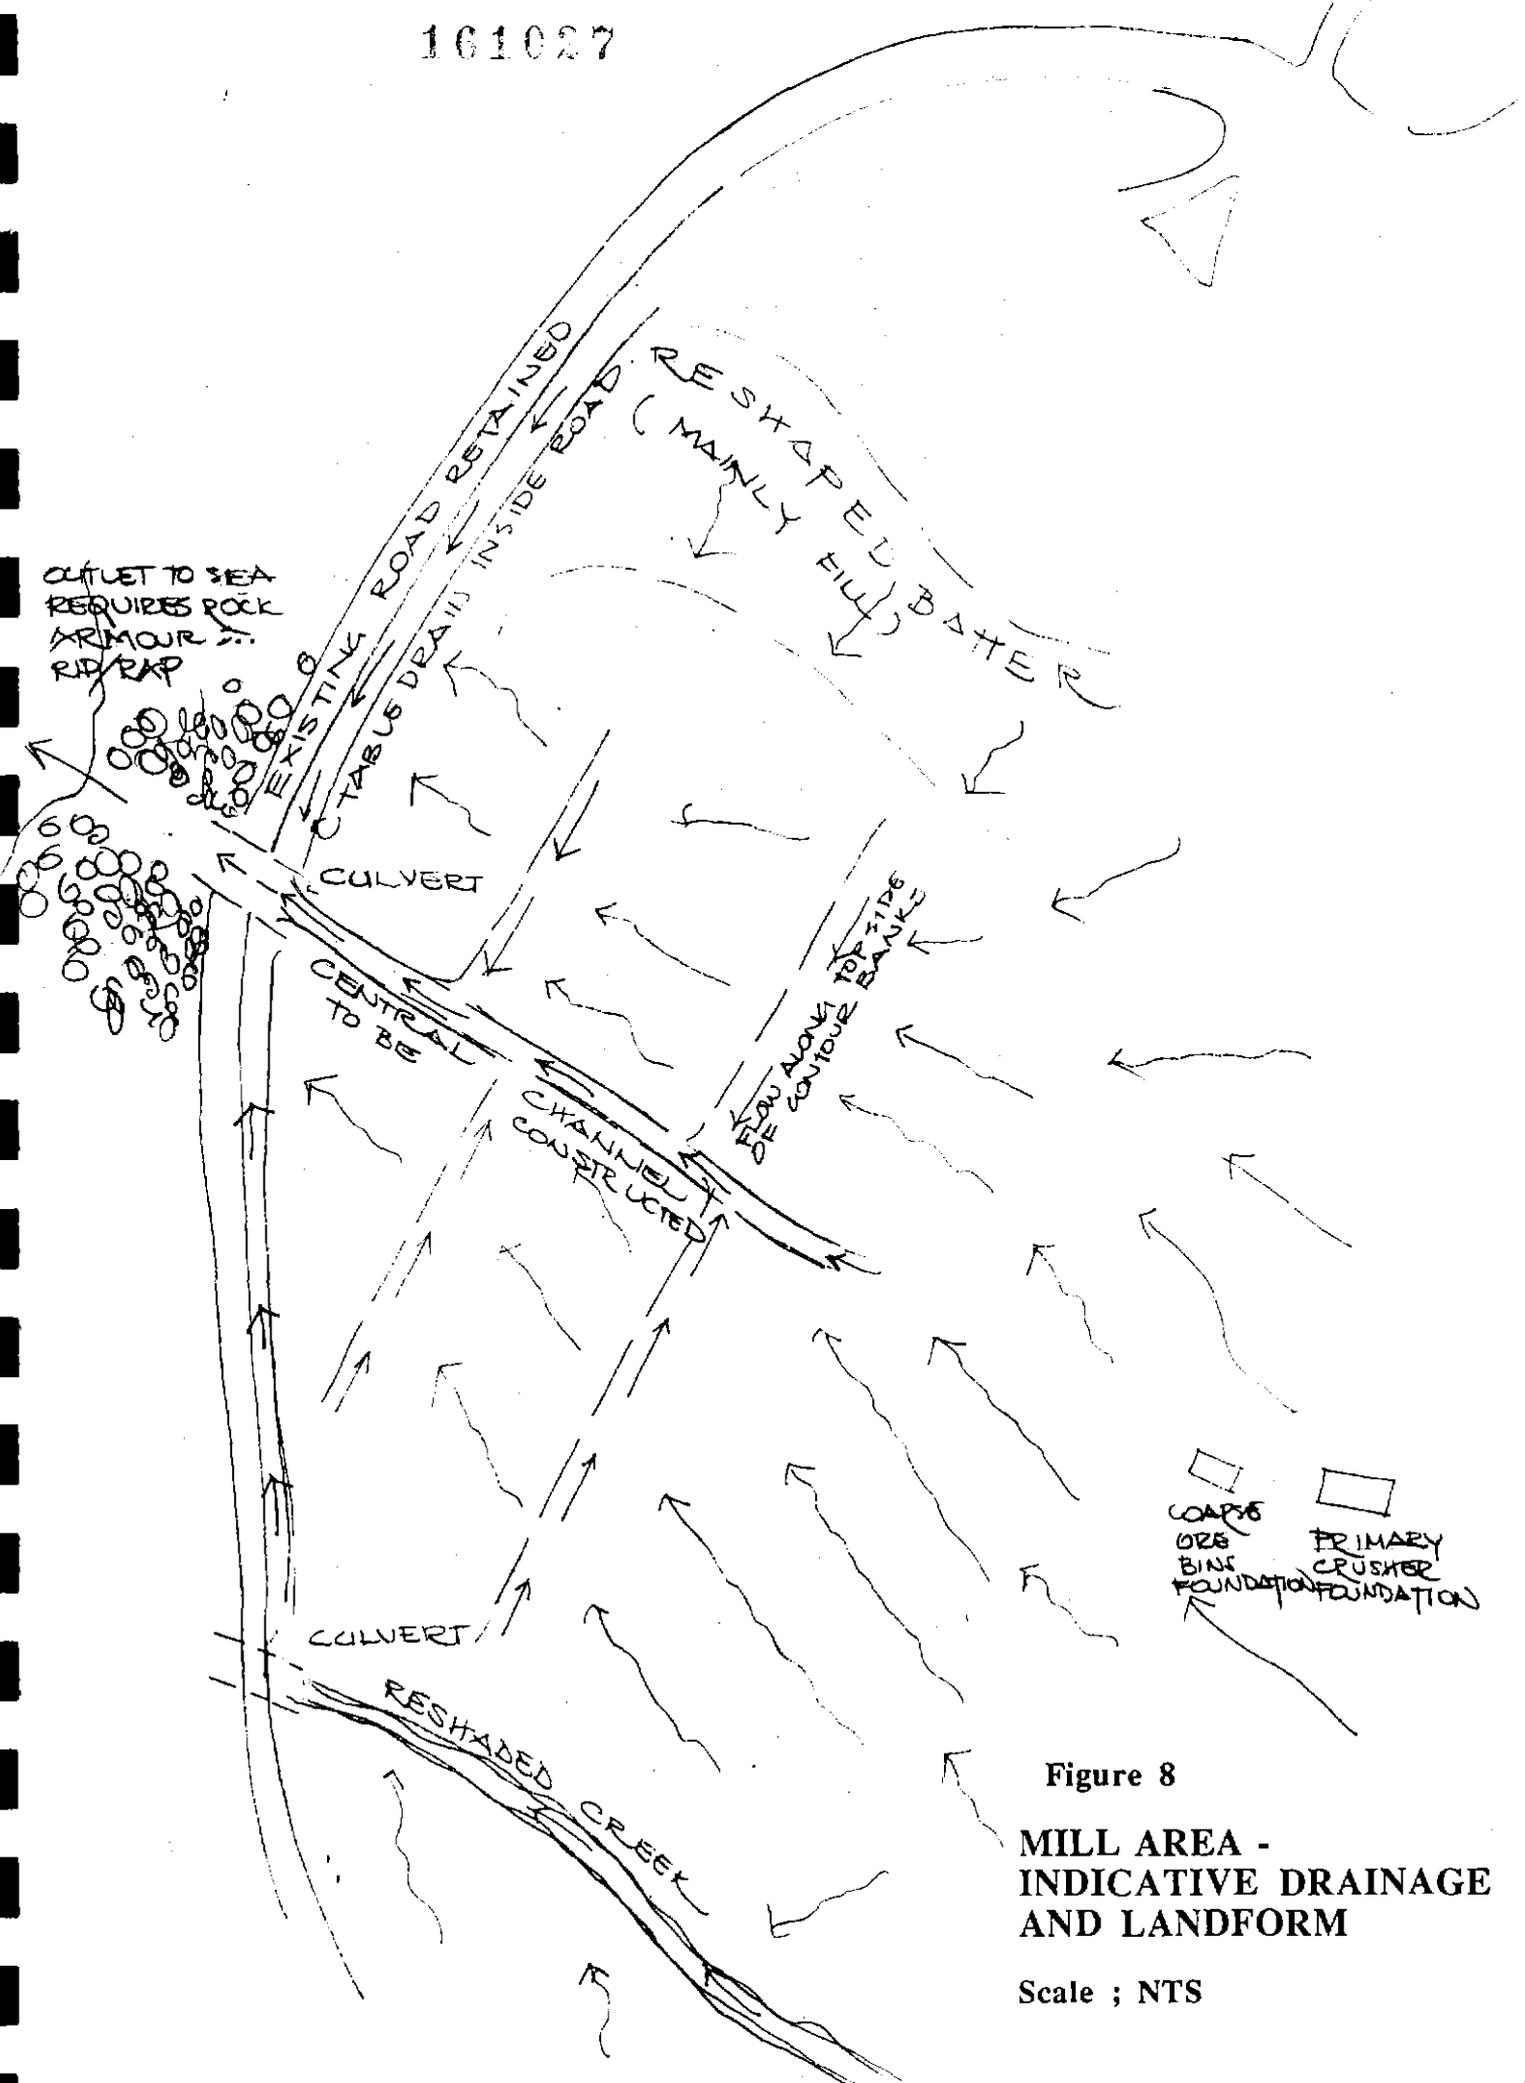
Figure 8

MILL AREA -  
INDICATIVE DRAINAGE  
AND LANDFORM

A site drainage plan is shown in Figure 8. This includes the provision for the long term groundwater drainage (from the Dolphin Pit and underground workings) which will flow from the services rise and an overflow channel for the possible blocking of the river culvert. Flow rates in the vicinity of 1 to 2 L/sec are anticipated.

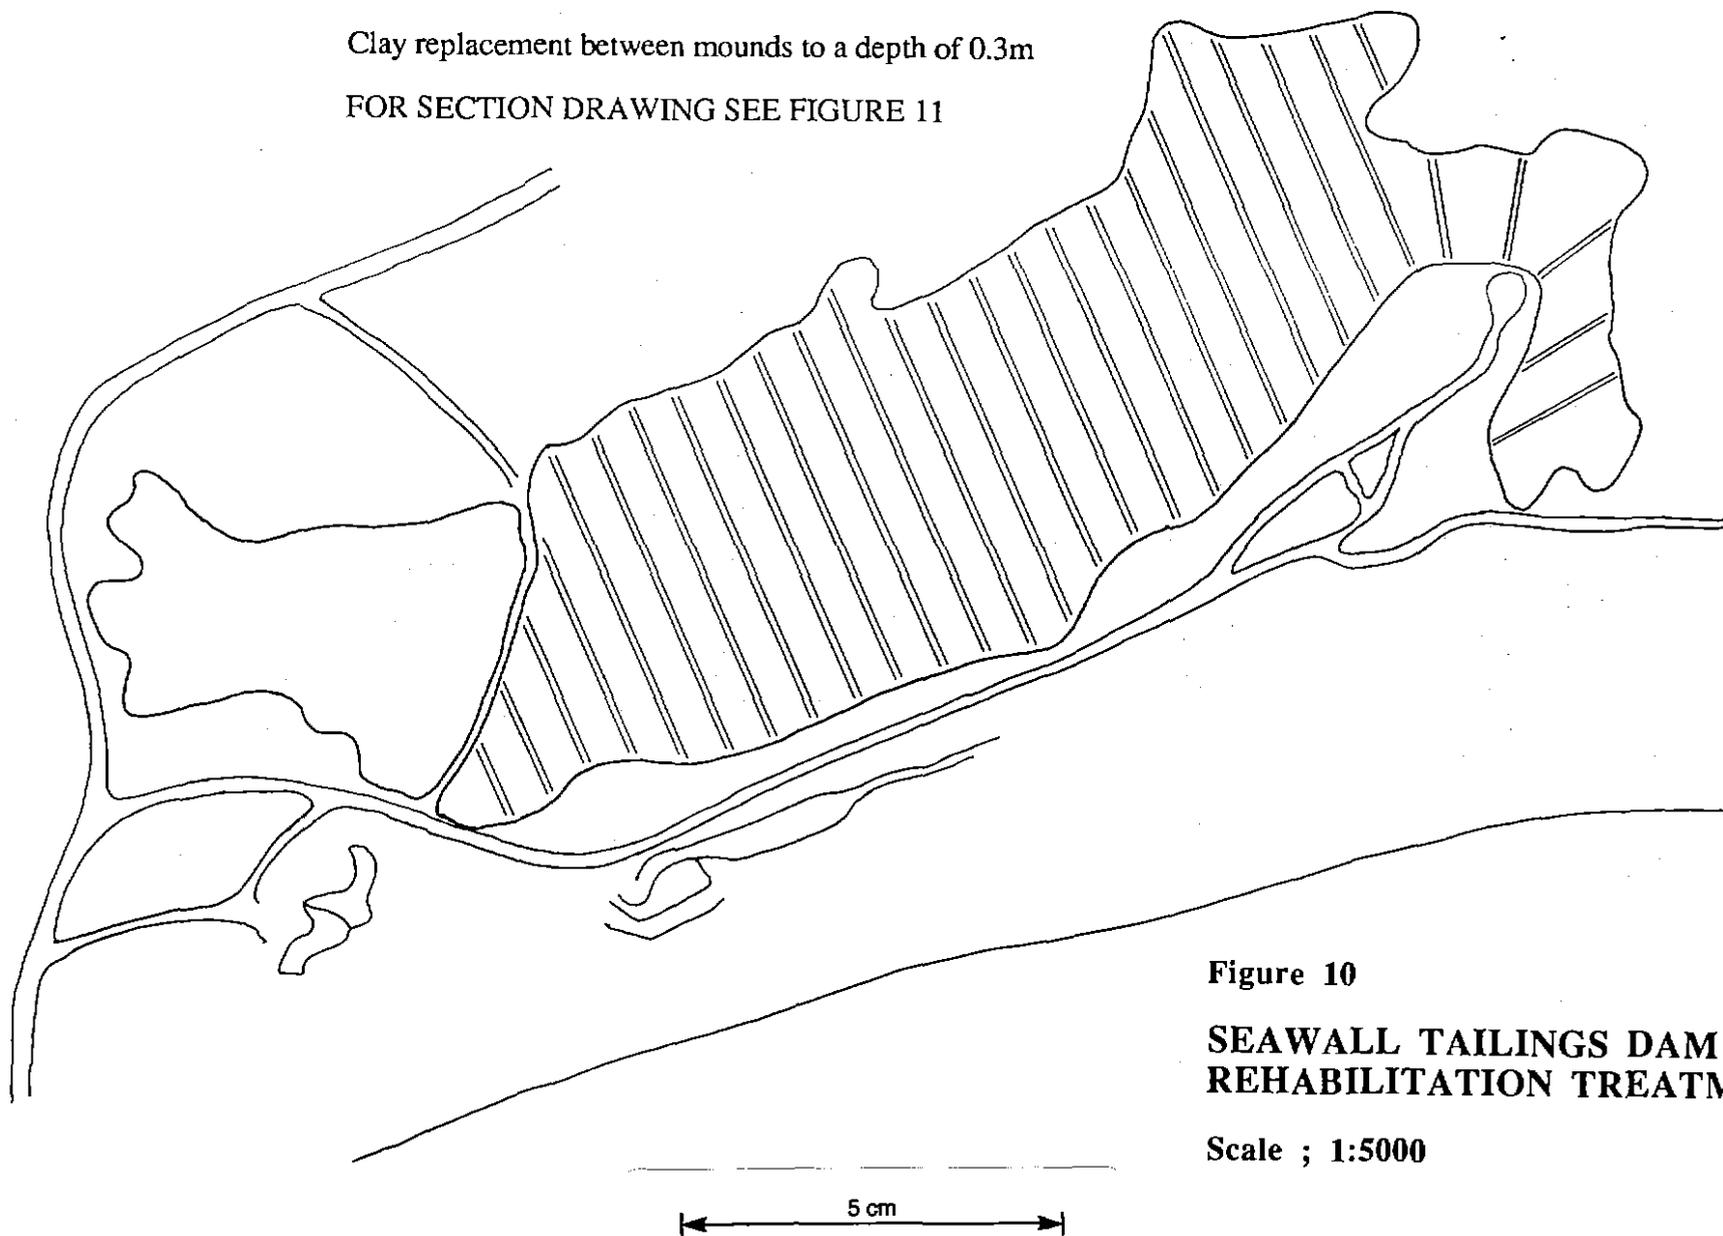
Figure 10

Clay replacement between mounds to a depth of 0.3m

**SEAWALL TAILINGS DAM  
REHABILITATION TREATMENT**

The Separation Wall and the Sea Wall embankments will be used as a source of cover for the tailings surface. Overburden and clay from these sources will be placed in mounds (0.3-1.0 m in height) across the tailings deposit in a north-south direction perpendicular to the prevailing wind condition, at 15-20 m intervals. (see Figures 10 and 11). The principal reason behind the parallel mounds is to gain access on the tailings surface. The mounds will also act to control exposure to wind.

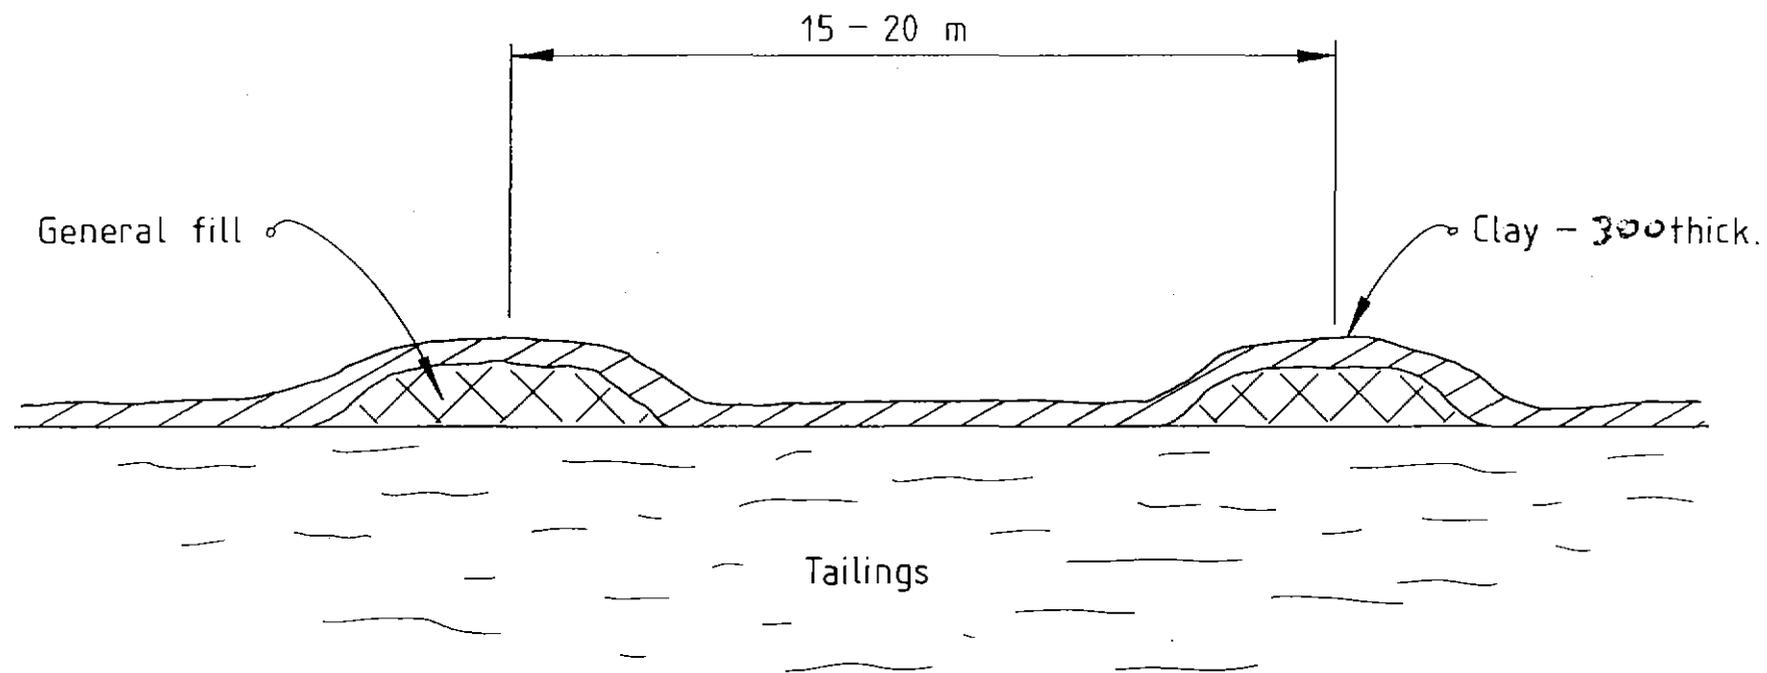
Figure 11

SEAWALL TAILINGS DAM  
REHABILITATION TREATMENT - Section

FOR SECTION DRAWING SEE FIGURE 11

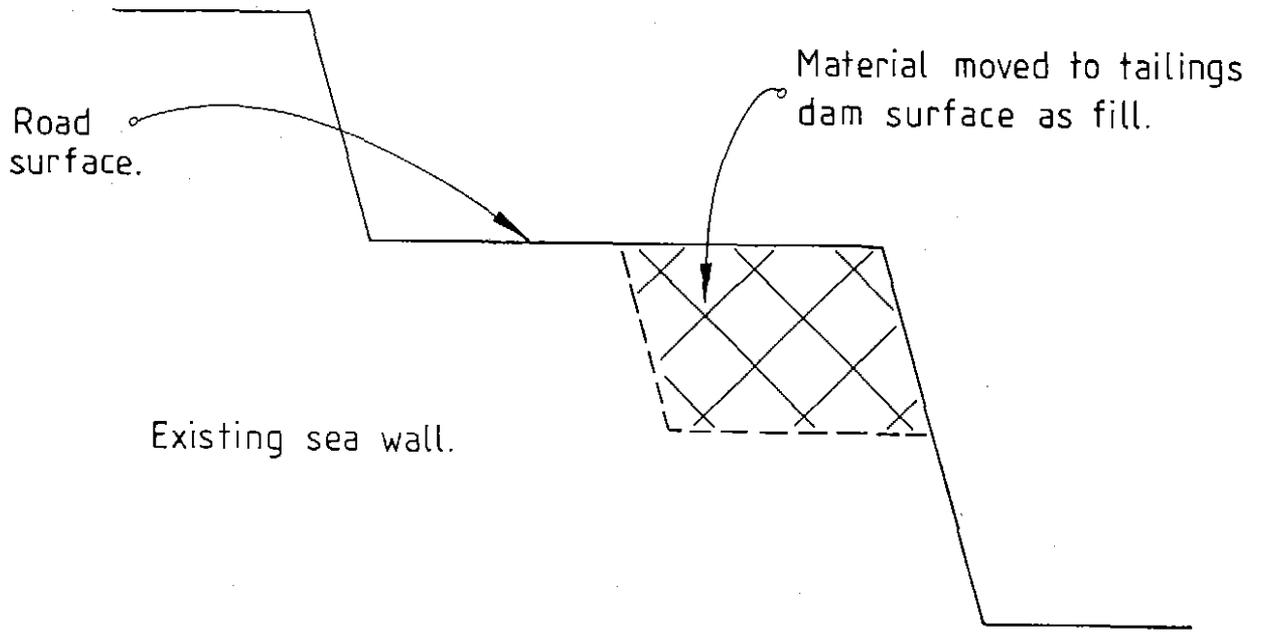
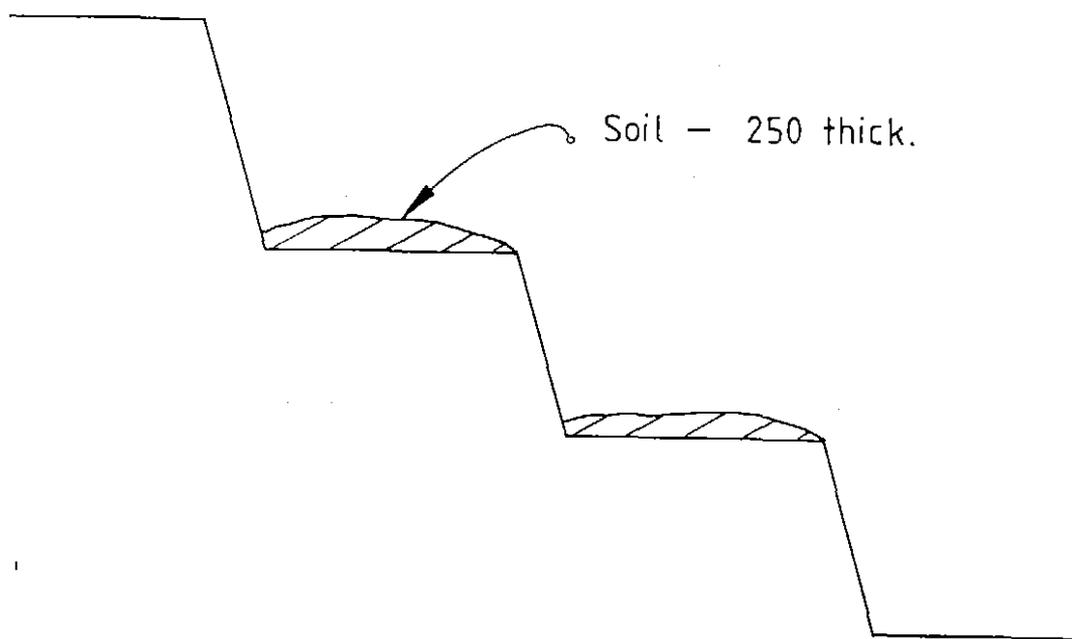
Figure 12

SEA WALL BENCH TREATMENT

The outer face of the Seawall Embankment will have a bench constructed in the eroding tailings, in order to control existing erosion. The bench will be constructed by an excavator reaching down from the access road as indicated in Figure 12. The bench and created batters will be covered by clay.

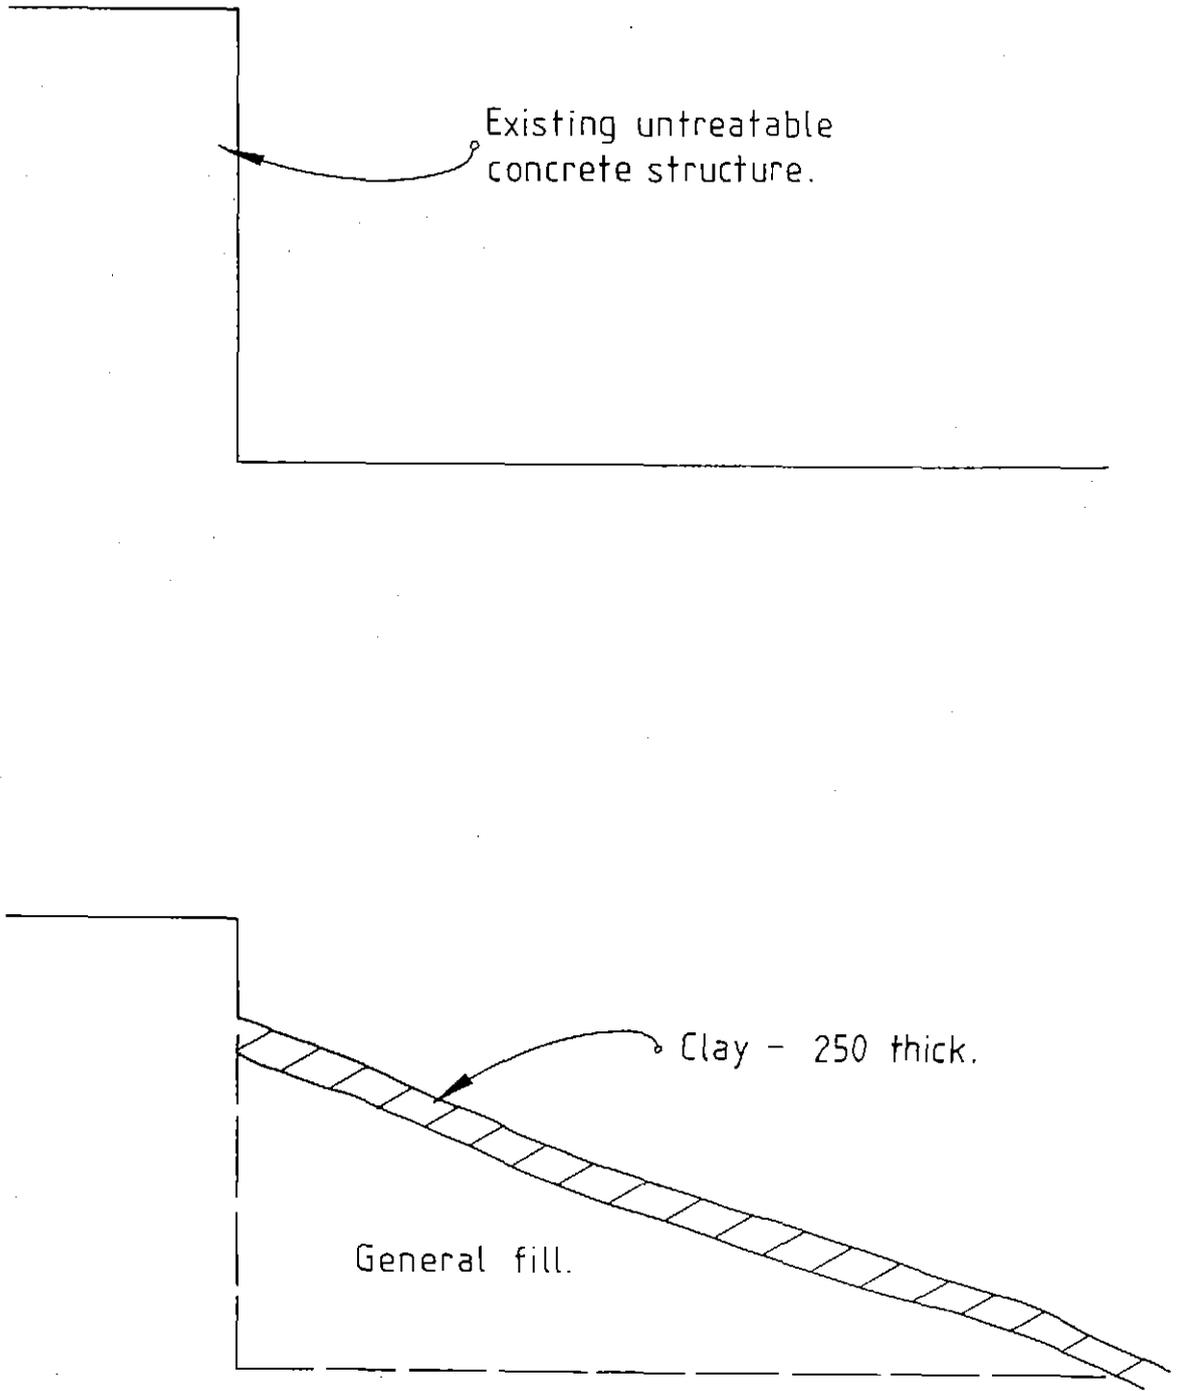
Figure A1

CONCRETE FOUNDATION TREATMENT

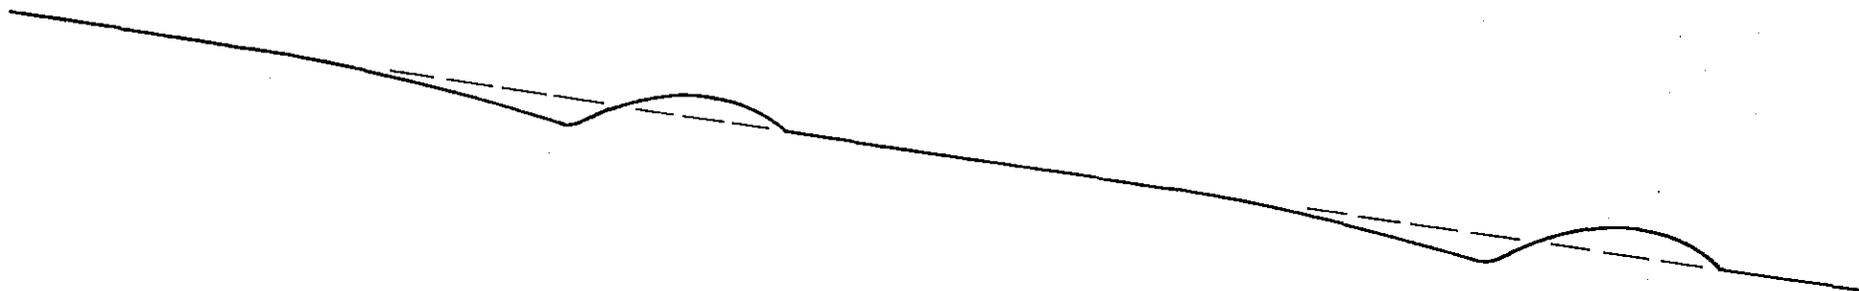
TYPICAL GRIPPING CONSTRUCTION

1. Water discharges 90° to road direction.
2. The lowest point of the grip mound must be higher than the discharge point.
3. --- Denotes the original road surface.

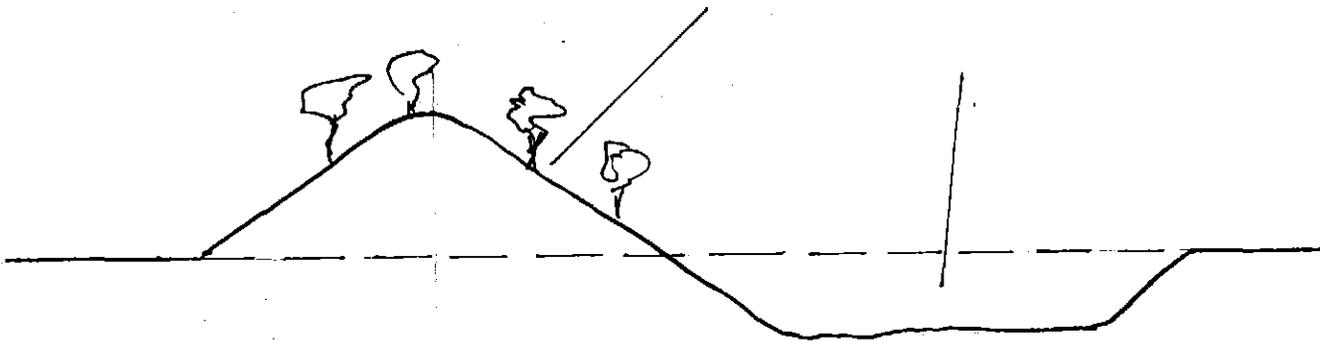
Figure A3

Bund wall minimum of 1.75m high . Side slopes 1:1.5  
Constructed from excavated material and/or rock.  
Covered with topsoil where available.

**DOLPHIN PIT BUND**
