GEOPEKO LIMITED  
KING ISLAND GROUP

No. KG2-02-023

DOLPHIN MINE  
C LENS HANGINGWALL  
PLAN PROJECTION  
ROCK STRENGTH PARAMETERS

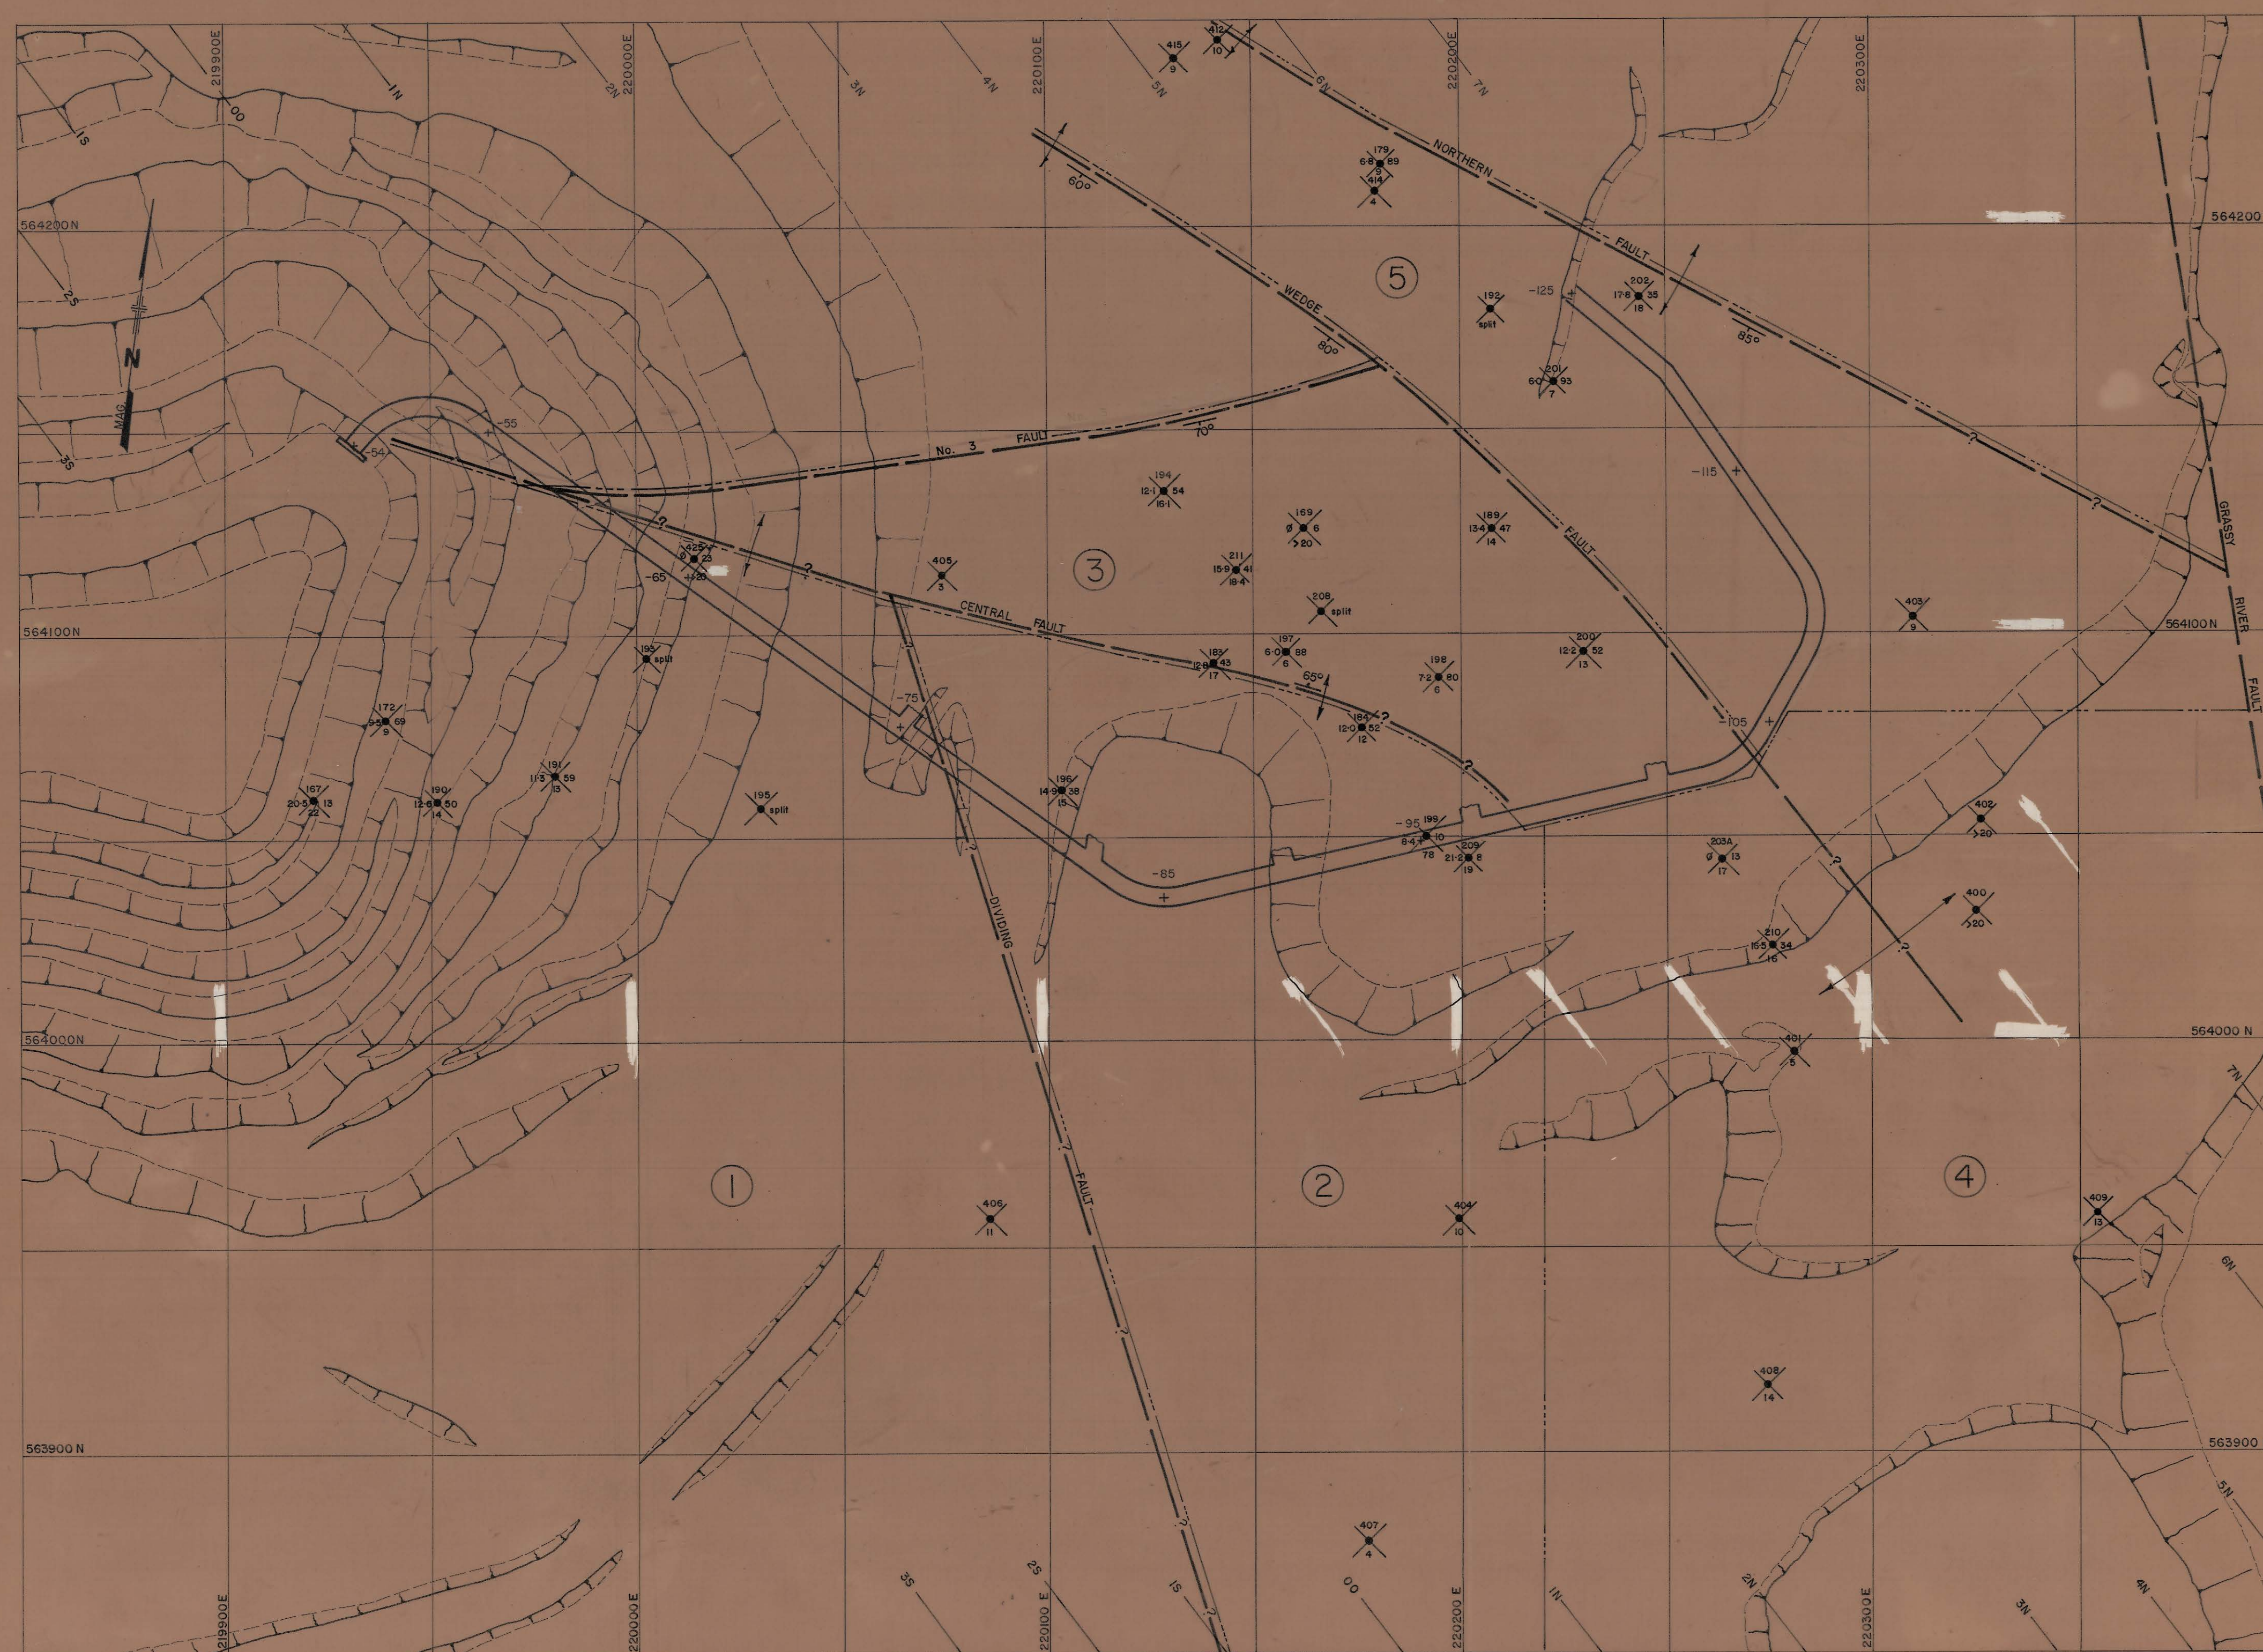
FIG. 7

## GROUND STABILITY CONDITIONS
