S.C.T.M.C.N.L.
 INCLINED LONGITUDINAL PROJECTION - LOOKING WEST
 H/W SYSTEM - N#2 VEIN AND WEST H/W VEIN
 WIDTH CONTOUR DIAGRAM

FIG. 9

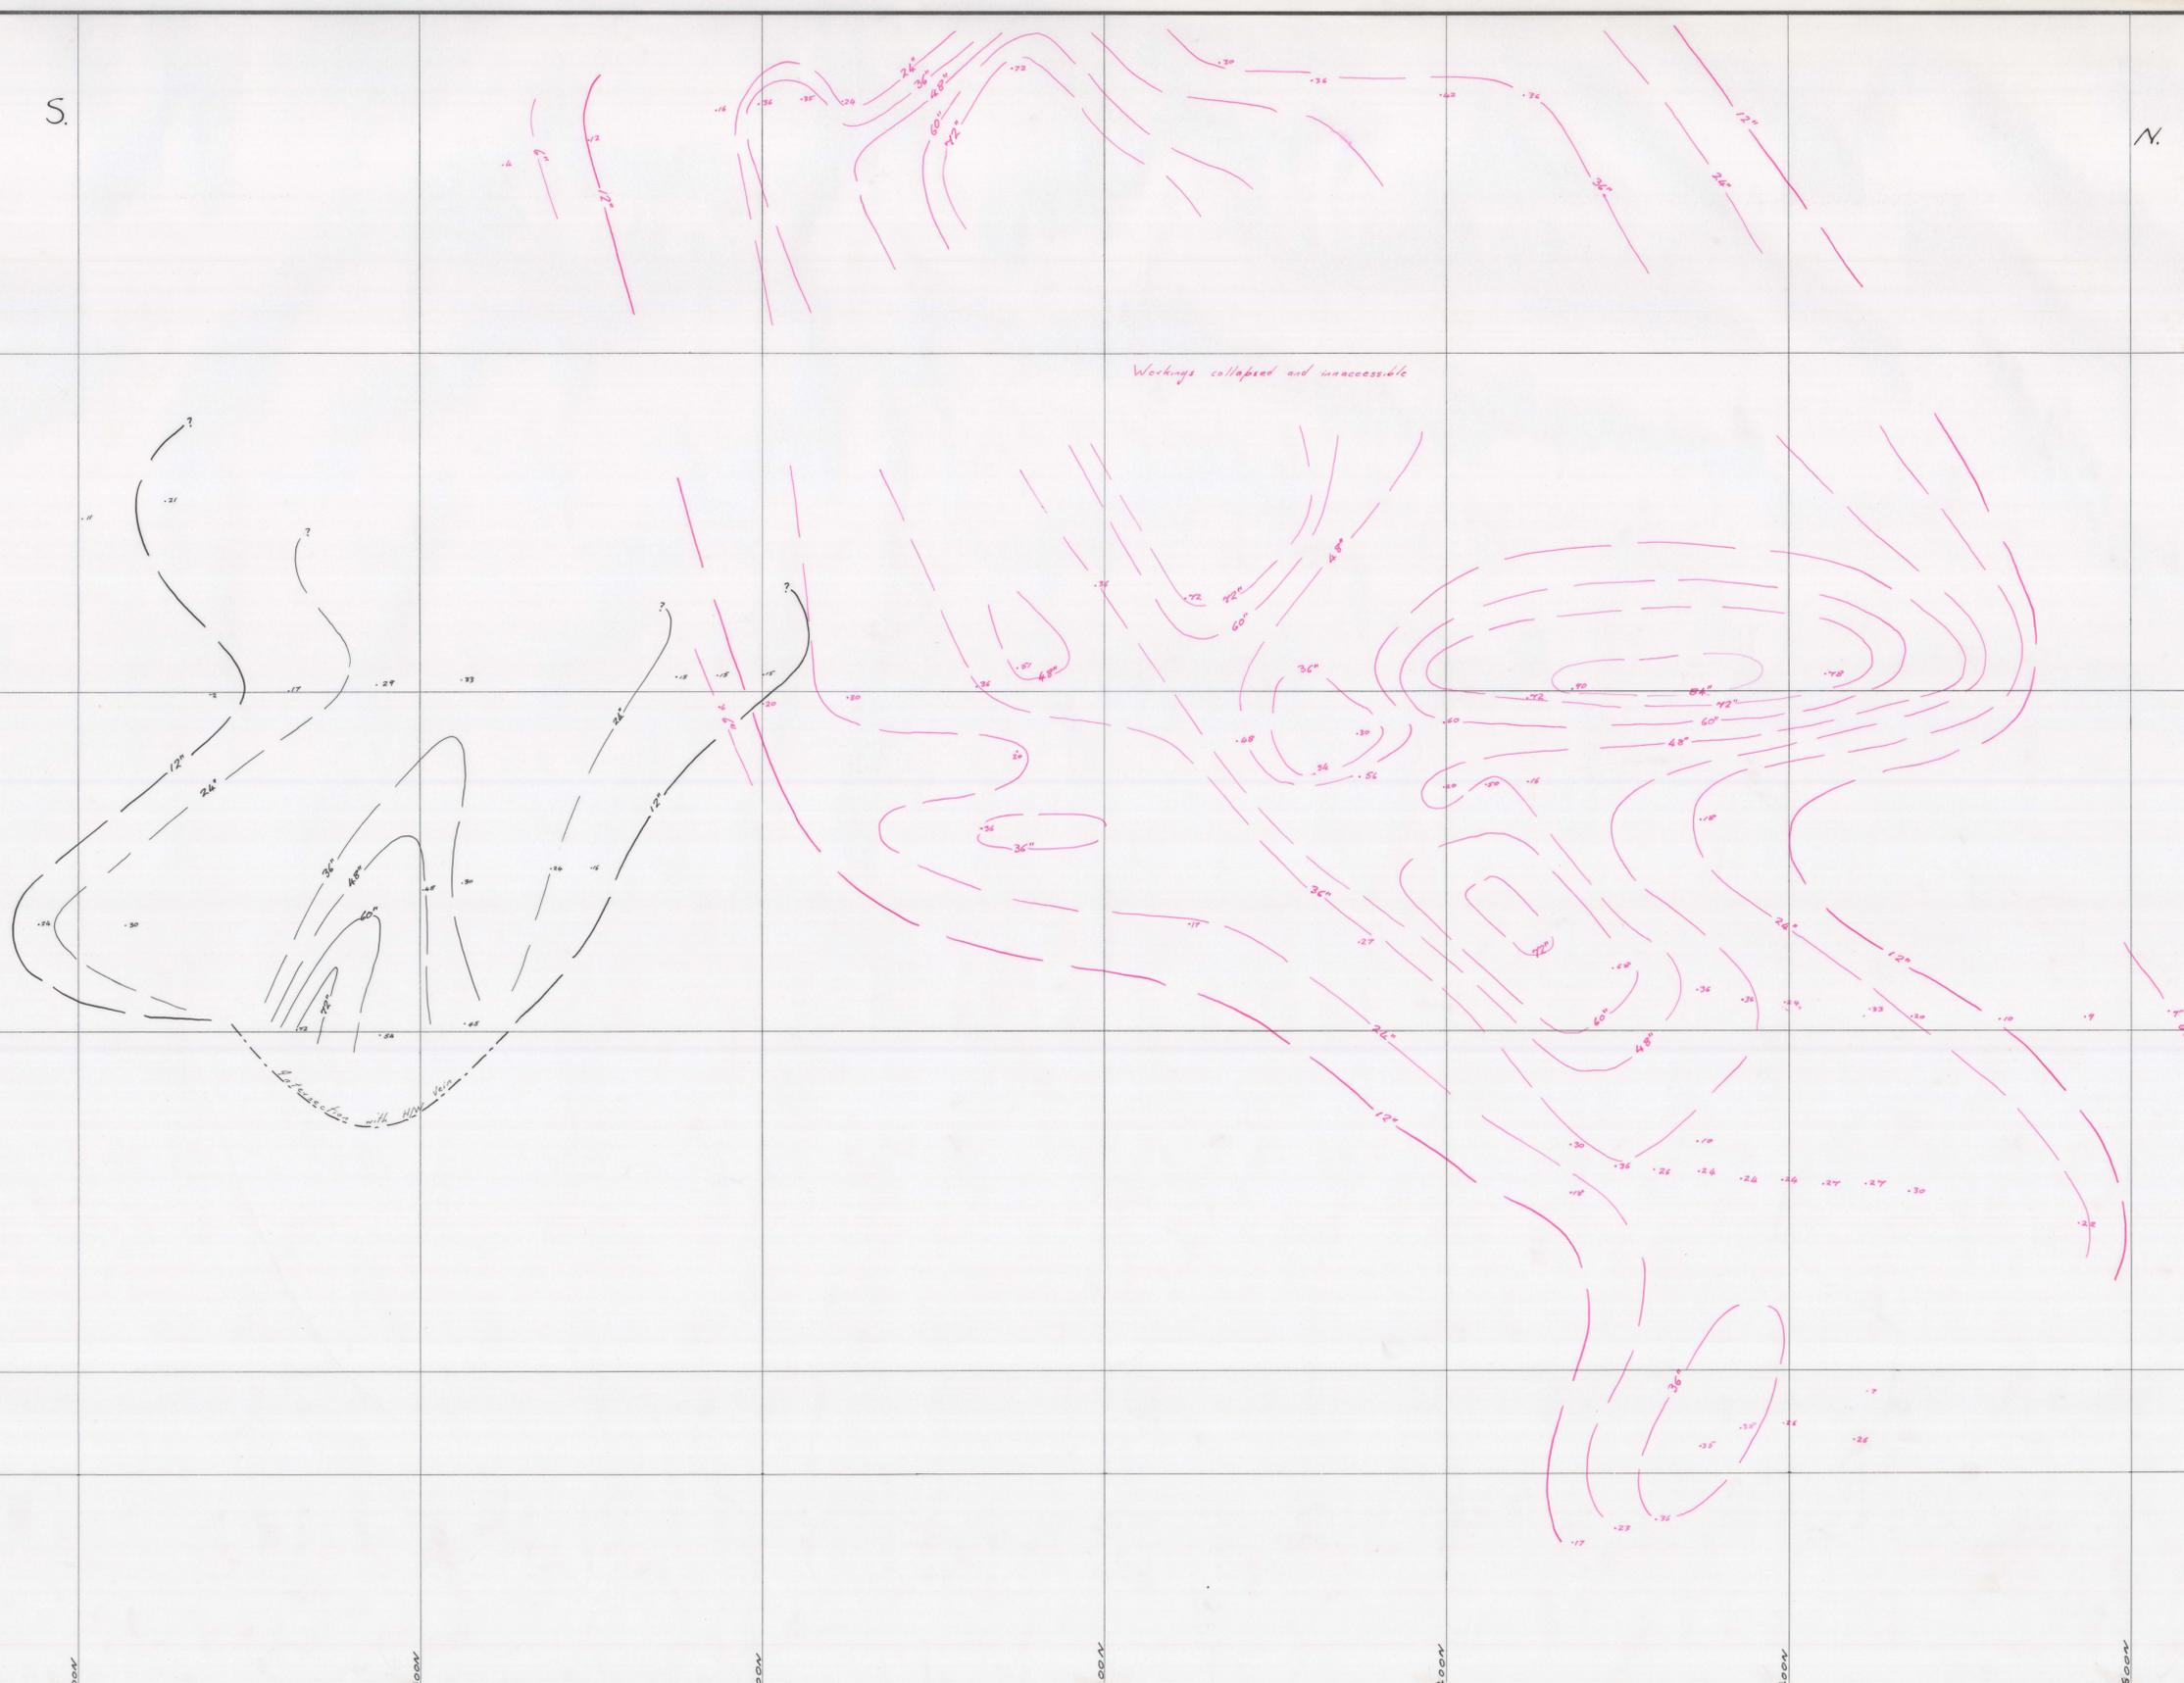
Workings collapsed and inaccessible

Irregularities with H/W vein
