## Examination of a proposed subdivision at Orana Place, North Riverside

by *W. L. Matthews*

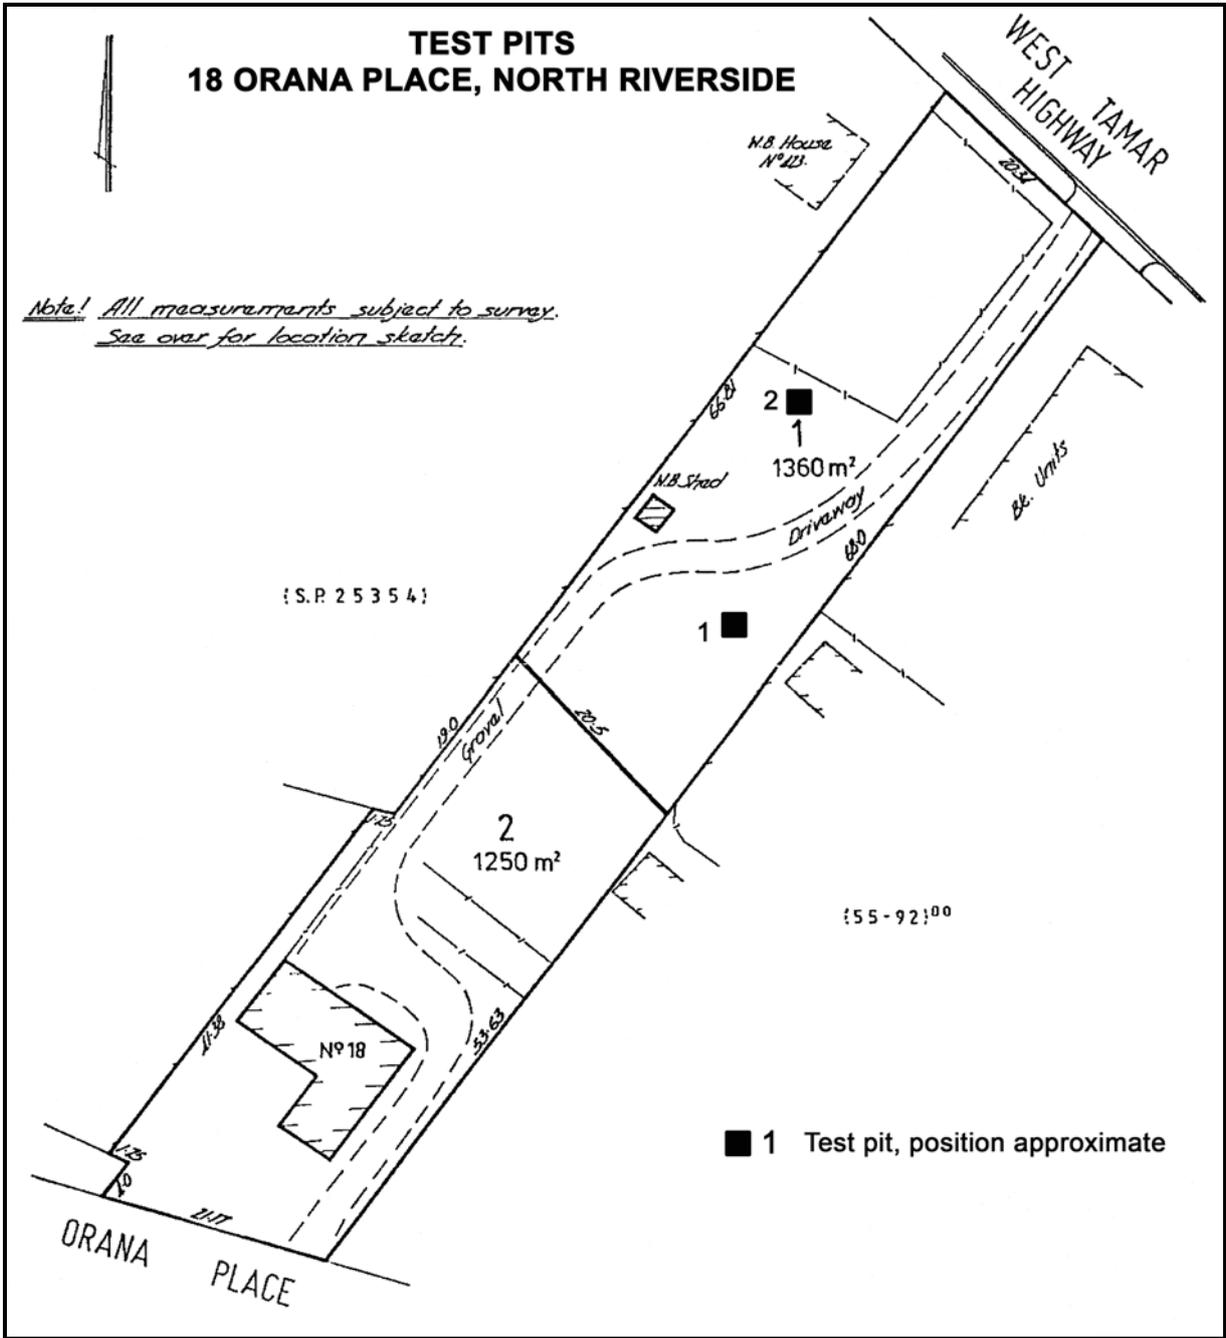
# TEST PITS 18 ORANA PLACE, NORTH RIVERSIDE

Two test pits have been dug on a new lot at a proposed subdivision at 18 Orana Place, North Riverside. The approximate positions of these pits are shown on Figure 1 with logs given in Appendix 1.

*Note! All measurements subject to survey.  
See over for location sketch.*
