Test pits at a proposed subdivision at Creamery Road, Sulphur Creek

W. L. Matthews

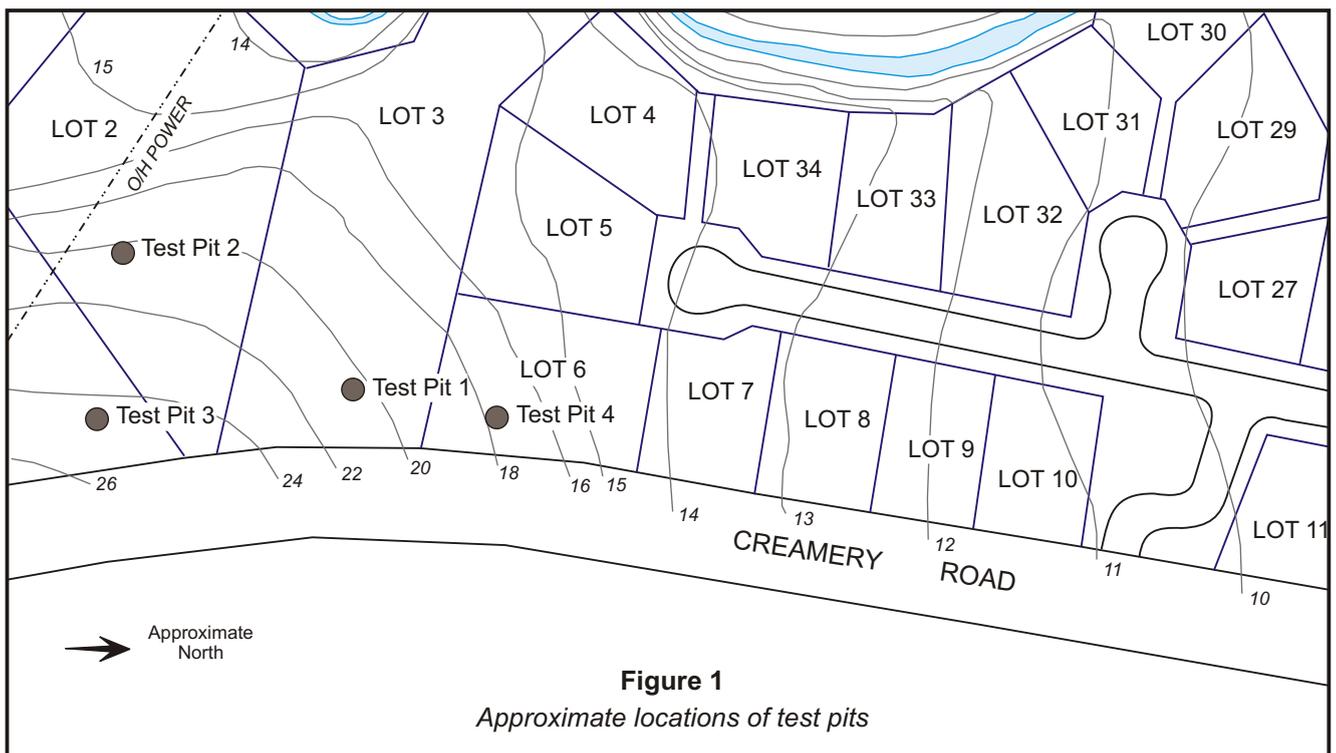
Four test pits were dug on the site of a proposed subdivision at Creamery Road, Sulphur Creek (418500 mE, 5449800 mN), to examine subsurface conditions. Brief descriptions of the material encountered are attached; the approximate locations of the pits are shown on Figure 1.
