# **The effects of waste disposal on groundwater quality in Tasmania**

## **Bridport sewage lagoons**

**Tasmanian Geological  
Survey Record 2002/01**

# Groundwater quality investigations at the Bridport sewage lagoons

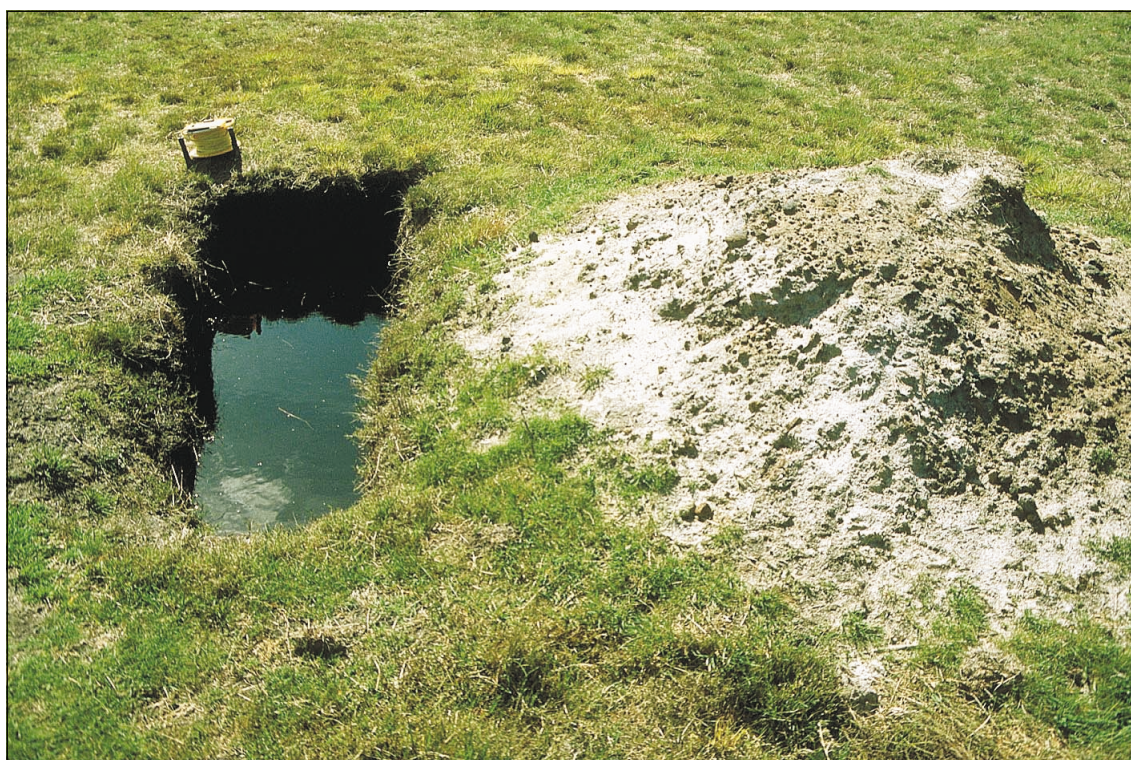
**Plate 2**

*Shallow standing water level (0.38 m below ground level) observed in the test pit excavated by the Dorset Council 26 m north of BSL2000/6.*

Groundwater was encountered between 1.2 and 3.0 m depth across the site. A perched water table was intercepted in hole BSL2000/4 at 1.2 m and hole BSL2000/5 was installed specifically to monitor this perched water table. Flow during drilling indicated that the groundwater in all boreholes was unconfined. A shallow standing water level (0.38 m below ground level) was observed in the test pit excavated and left open by the Dorset Council 26 m north of BSL2000/6 (Plate 2). Recorded yields from the bores ranged between 0.005 to 0.015 l/s. Figure 5 shows a cross-section and related standing water level on 20 August 2001.

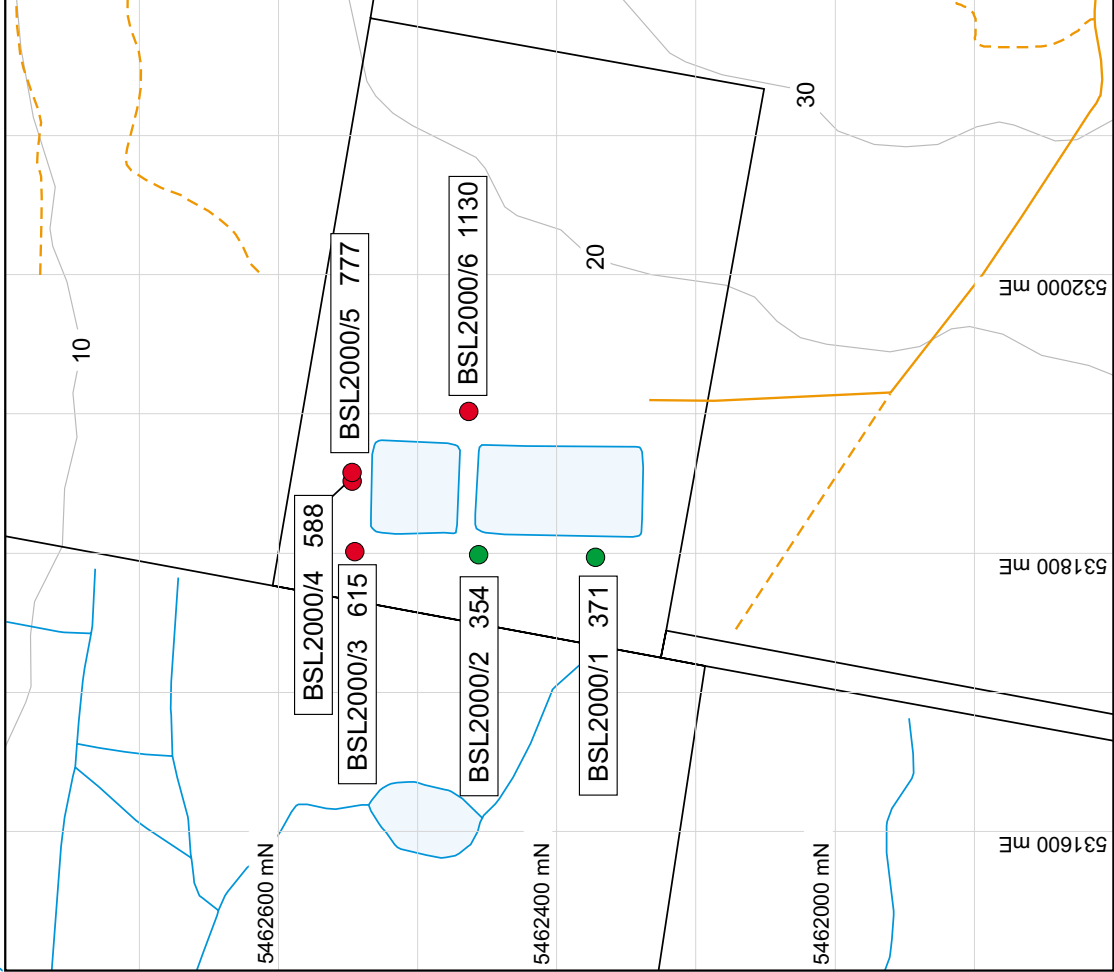
**Bridport sewage lagoons**  
**November 2000**  
**Conductivity ( $\mu\text{S/cm}$ )**

for pH ranged between 5.0 and 6.3 while conductivity values ranged between 371 and 1130 µS/cm. Analytical results are presented on site maps in Appendix 3.
