The effects of waste disposal on groundwater quality in Tasmania

Stanley sewage lagoons

Tasmanian Geological
Survey Record 2002/08

Groundwater quality investigations at the Stanley sewage lagoons

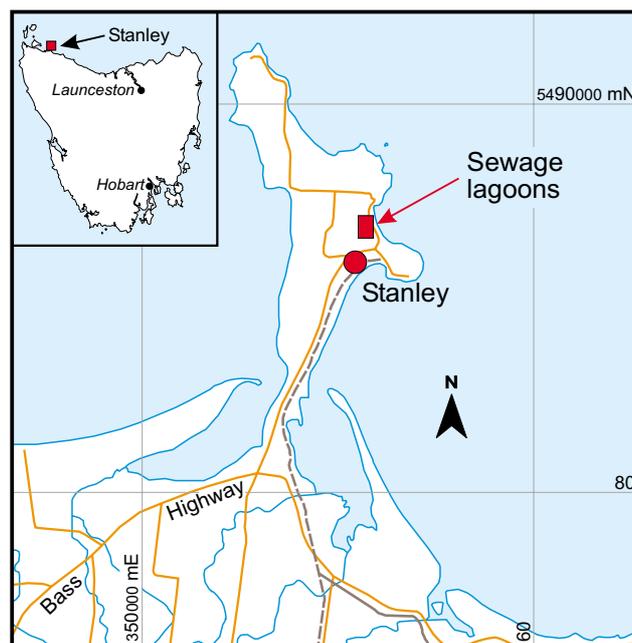
Figure 1

Location of the Stanley sewage lagoons.

The Stanley sewage lagoons are clay lined and are located approximately 250 metres north of Stanley (354 800 mE, 5 486 800 mN) (fig. 1). The Department of Primary Industries, Water and Environment (DPIWE) currently license the facility.

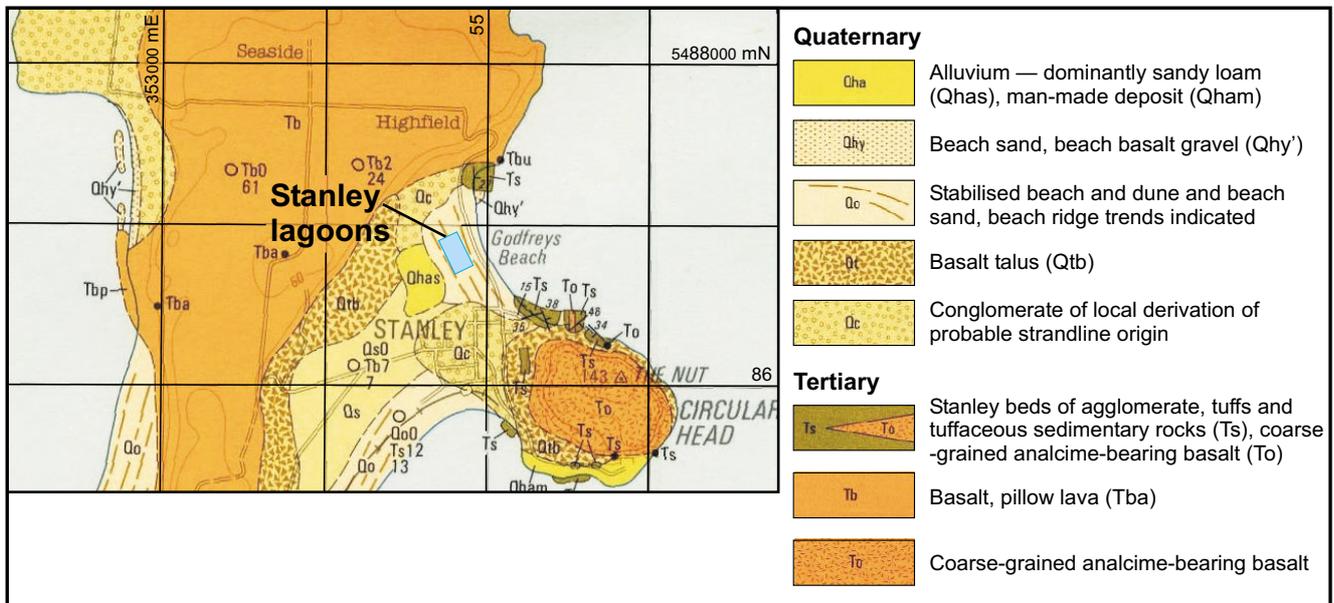
Figure 2

Extract from Smithton geological map (Lennox et al., 1982) of the local area and related geology.

The Tasmania Department of Mines 1:50 000 scale Smithton geological map (Lennox *et al.*, 1982) indicates that the geology of the Stanley area consists of Quaternary beach and dune sand (fig. 2). These deposits are suggested to have stabilised since the early Holocene.

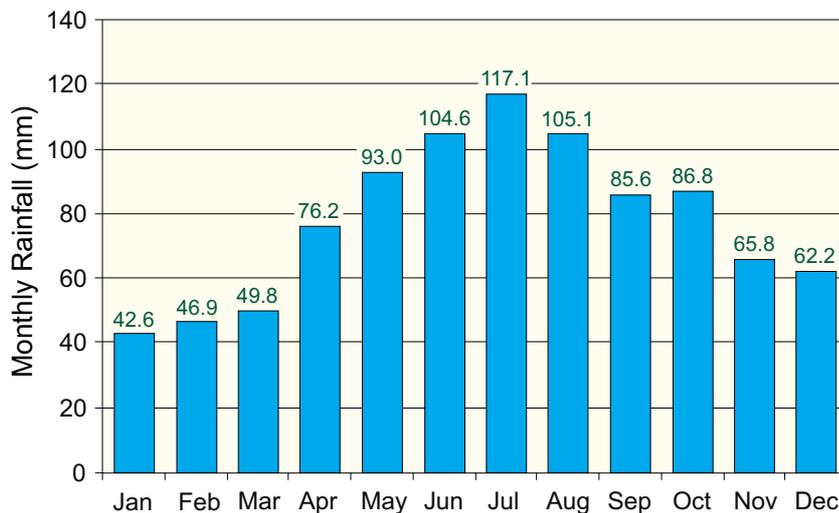
Figure 3

Average monthly rainfall for Australian Bureau of Meteorology rainfall station 091094, Stanley (Post Office).

The lagoons are located approximately 30 m west of Godfreys Beach and approximately 35 m east of marsh land which feeds a drainage line that discharges onto the northern end of Godfreys Beach. Australian Bureau of Meteorology rainfall station 091094 at Stanley (Post office) is the closest rainfall station to the site. The rainfall chart of average monthly recorded rainfall (fig. 3) shows that the average annual rainfall for the station is 935.7 mm.

The cross section (fig. 5) combined with the annual rainfall pattern (fig. 3) indicate that the water table is highly likely to interact with the lagoon liners on a seasonal basis. This may also occur in very high tidal events.

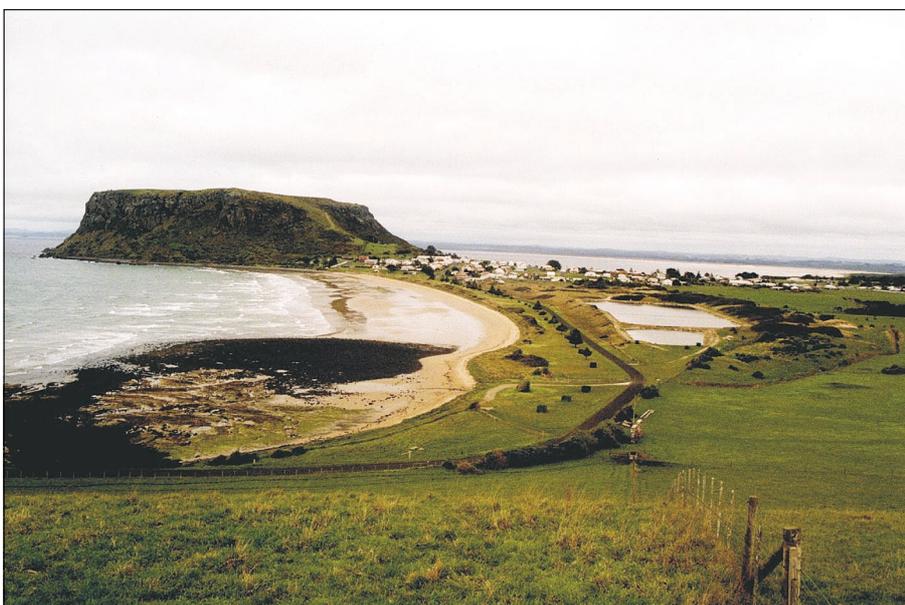
The local setting of the Stanley sewage lagoons depicting Godfreys Beach and the Tertiary basalt Stanley Nut.

During early years of operation, the northern maturation lagoon (lagoon number 3) was lined with additional bentonite. Information was not available on the thickness of the liners and the designed hydraulic permeability. Each lagoon has a one metre cement wave wall constructed at surface level to prevent wave erosion damage. All three lagoons are located in geological materials consisting primarily of sand. Plate 1 shows the local setting of the sewage lagoons.

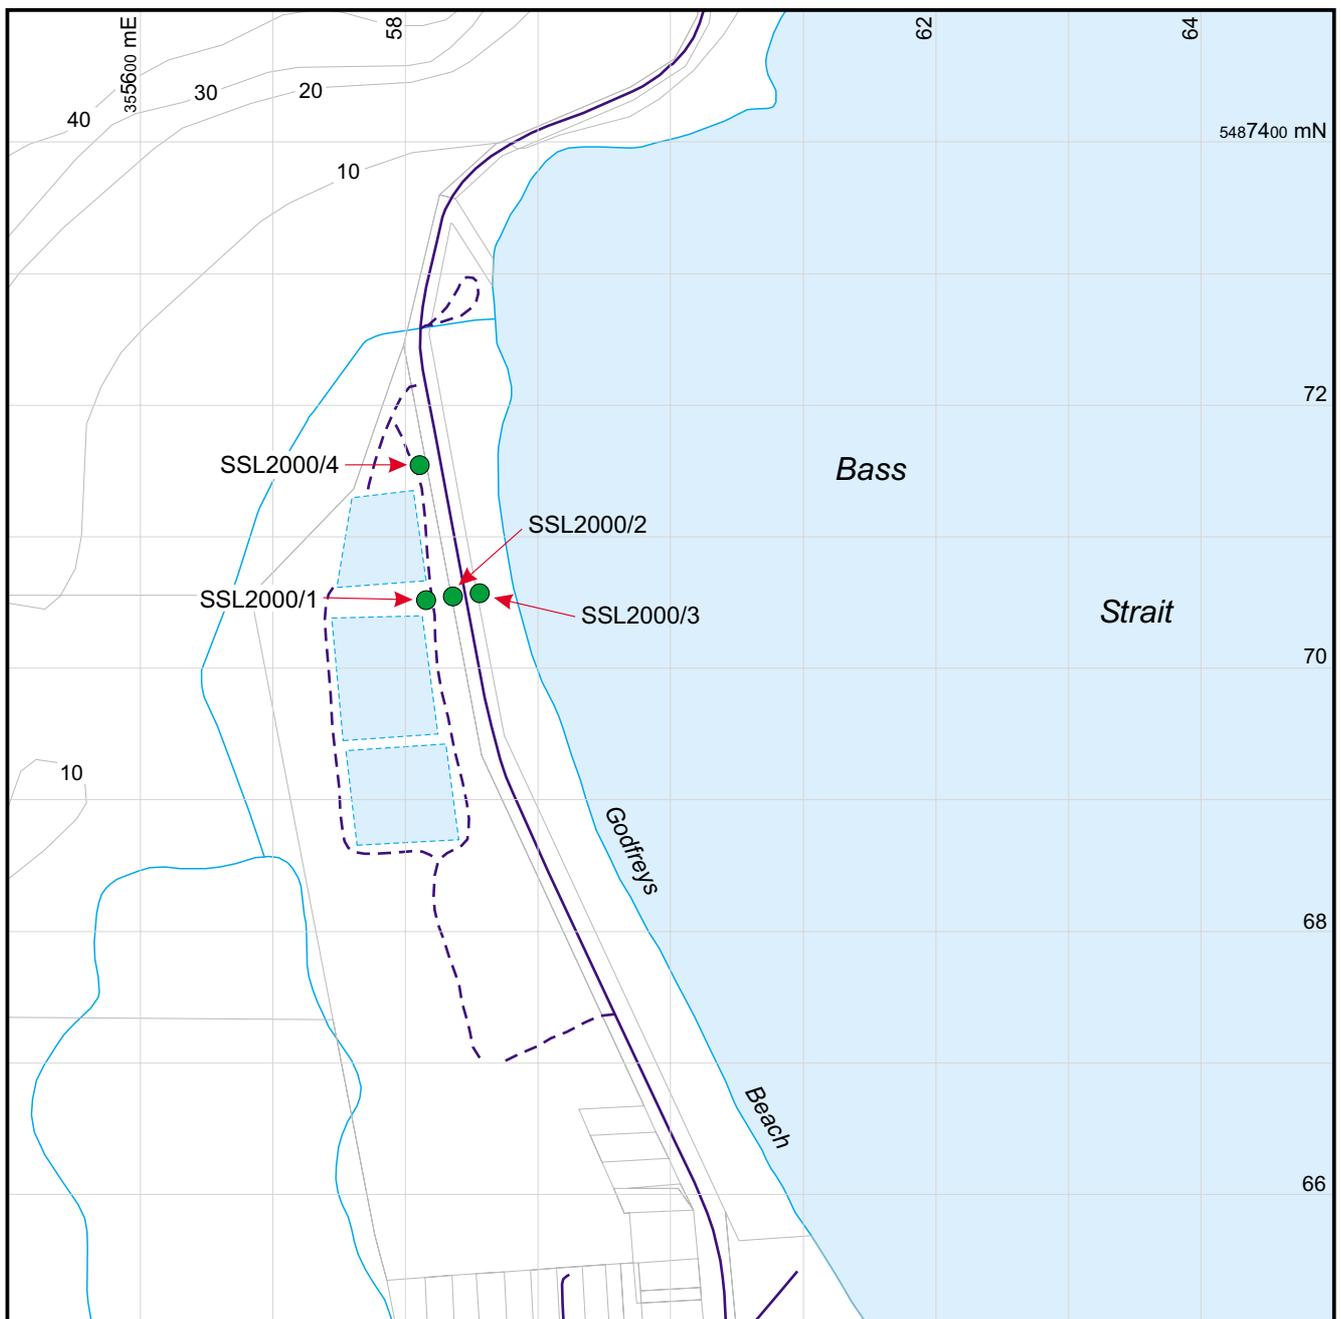
Figure 4

Locations of environmental monitoring bores installed at the Stanley sewage lagoons.

Four 120 mm diameter monitoring bores were auger drilled on 7 September 2000 for this project (fig. 4), with 50 mm casing being installed in each hole. All bores were logged in accordance with AS 1726-1993; engineering logs are presented in Appendix 1. Disturbed samples were collected at appropriate intervals and are stored in the MRT core shed.

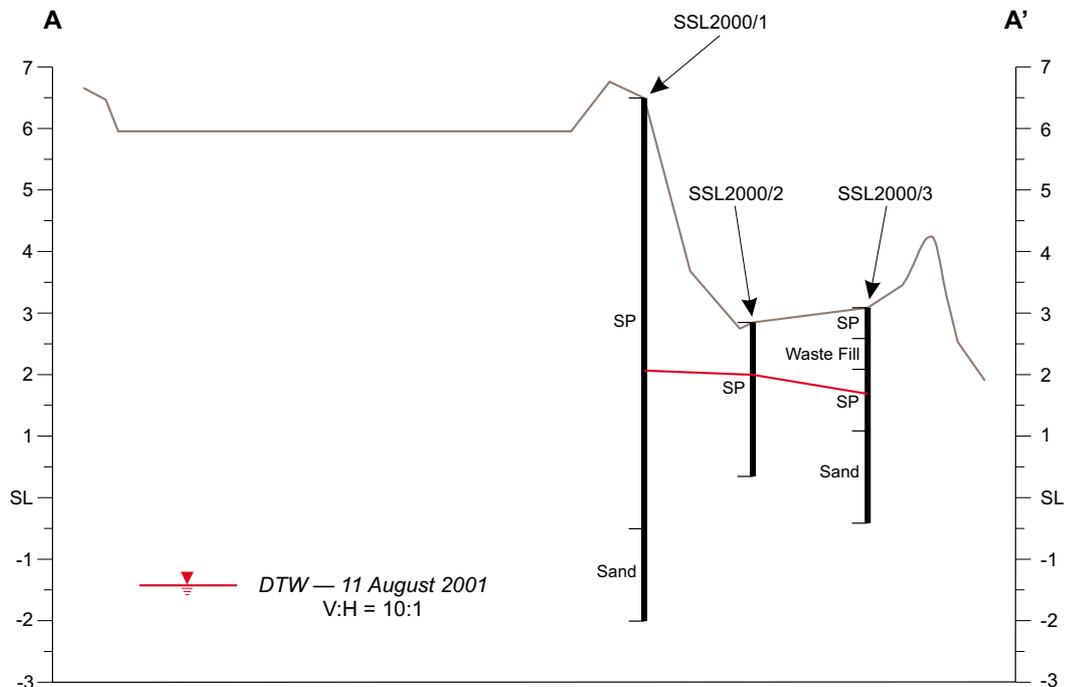
Cross-section and related standing water levels on 11 August 2001 for bores SSL2000/1, 2 and 3.

and SSL2000/3 was unconfined. Recorded yields of bores ranged between 0.048 to 0.721/s. Figure 5 shows a cross-section and related standing water levels on 11 August 2001 for bores SSL2000/1, SSL2000/2 and SSL2000/3.

Groundwater flow is interpreted as a tidally-controlled system between marshland to the west and Godfreys Beach, passing beneath the area of the lagoons. The cross section (fig. 5) supports this interpretation.

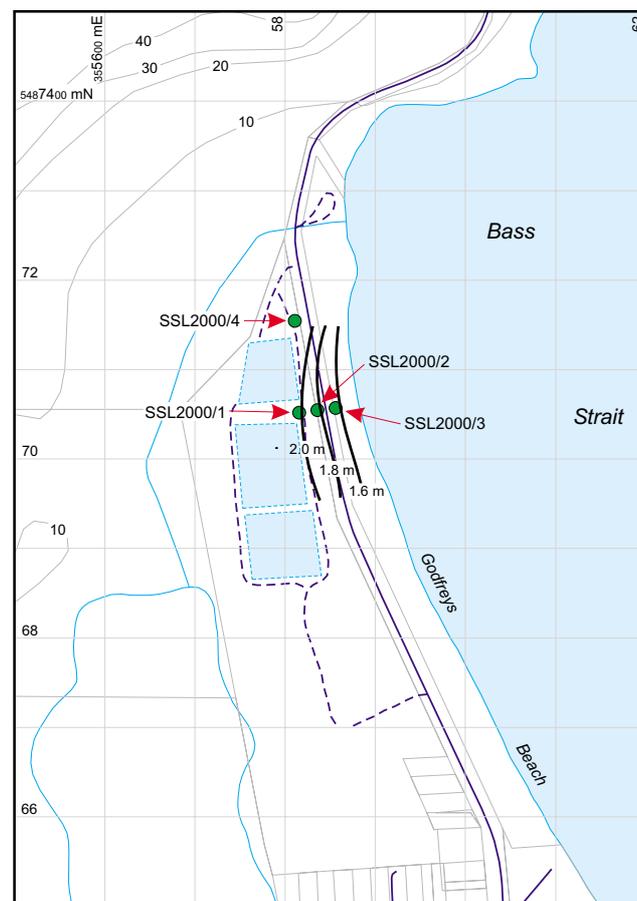
Interpretation of the piezometric surface based on surveyed heights and groundwater depths of the boreholes.

Figure 7 illustrates an interpretation of the piezometric surface based on surveyed heights and groundwater depths in the boreholes. Based on this linear interpretation, local groundwater flow is to the east of the lagoons towards Godfreys Beach. Recharge to the

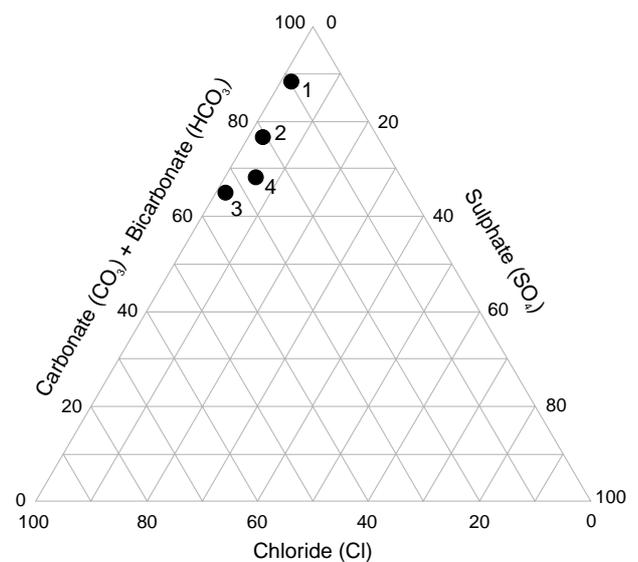
Figure 8

Anion Ternary plot for groundwater bores at the Stanley sewage lagoons. 1 - SSL2000/1; 2 - SSL2000/2; 3 - SSL000/3; 4 - average of all MRT records for groundwater in Quaternary coastal sand.

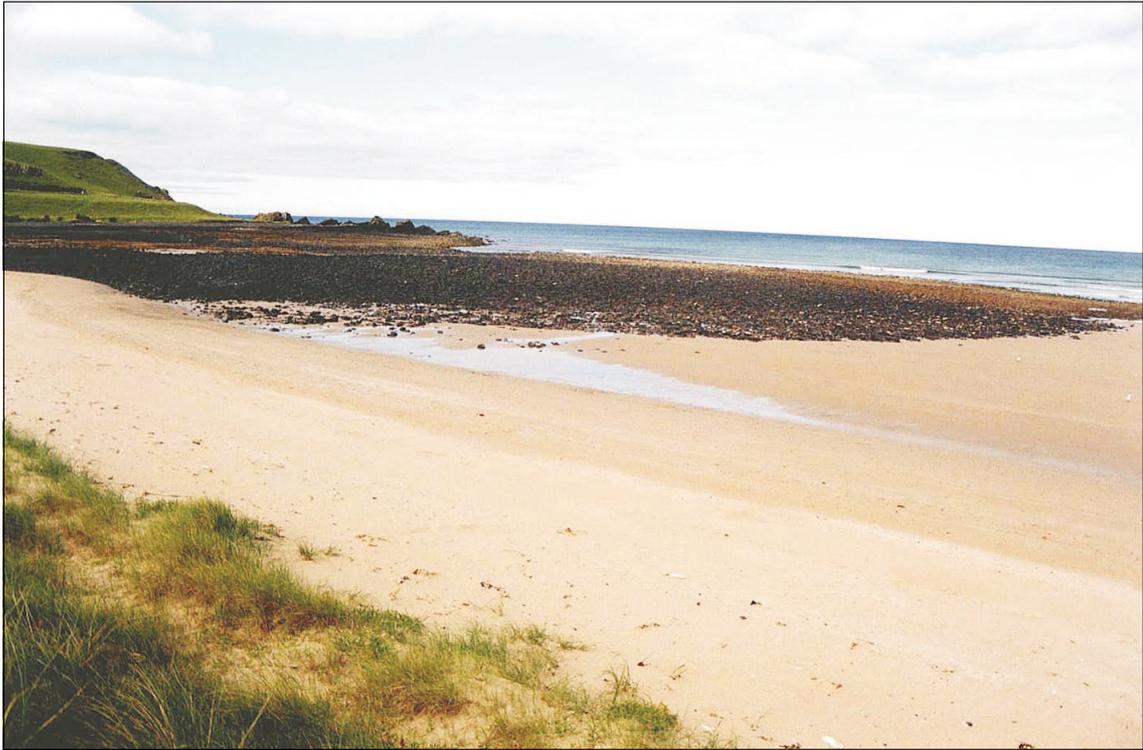
Plate 2

Spring soakage northeast of the sewage lagoons on Godfreys Beach at low tide, 11 August 2001.

Tidal effects most likely strongly influence this hydraulic system. Plates 2 and 3 show spring seepages on Godfreys Beach during low tide on 11 August 2001; these are interpreted as discharge points of the local hydrogeological system. This suggests that tidal movements affect groundwater flow.

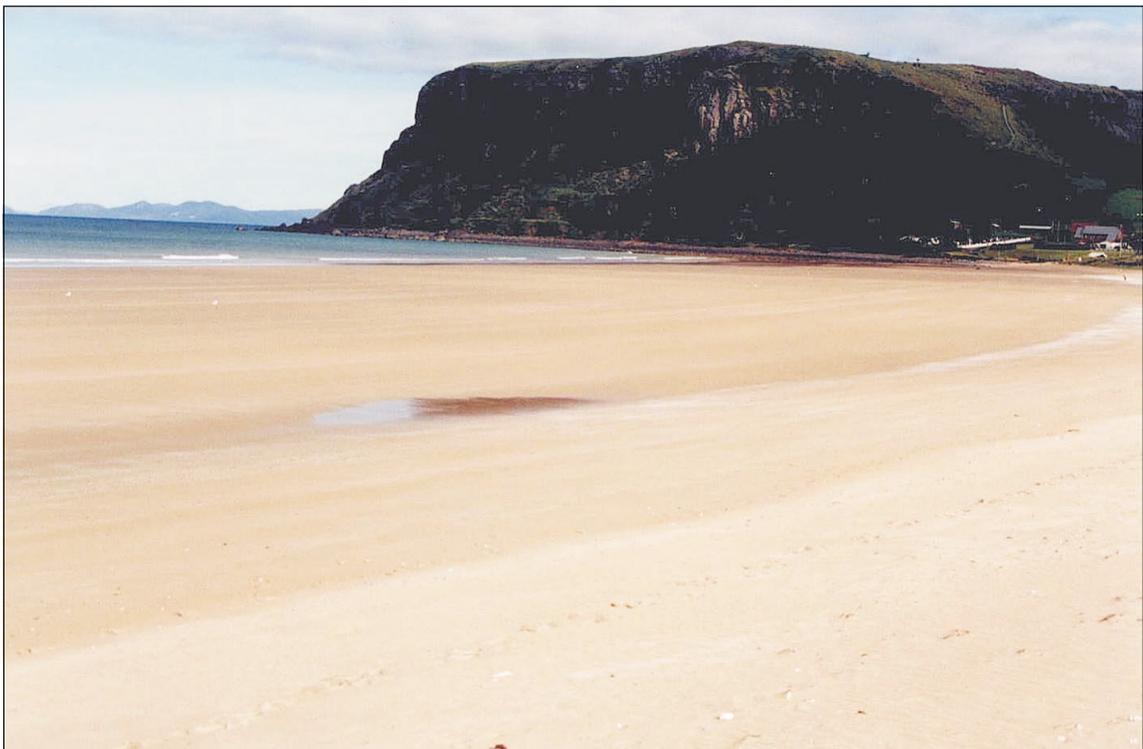
Plate 3

Spring soakage east of the sewage lagoons on Godfreys Beach at low tide, 11 August 2001.

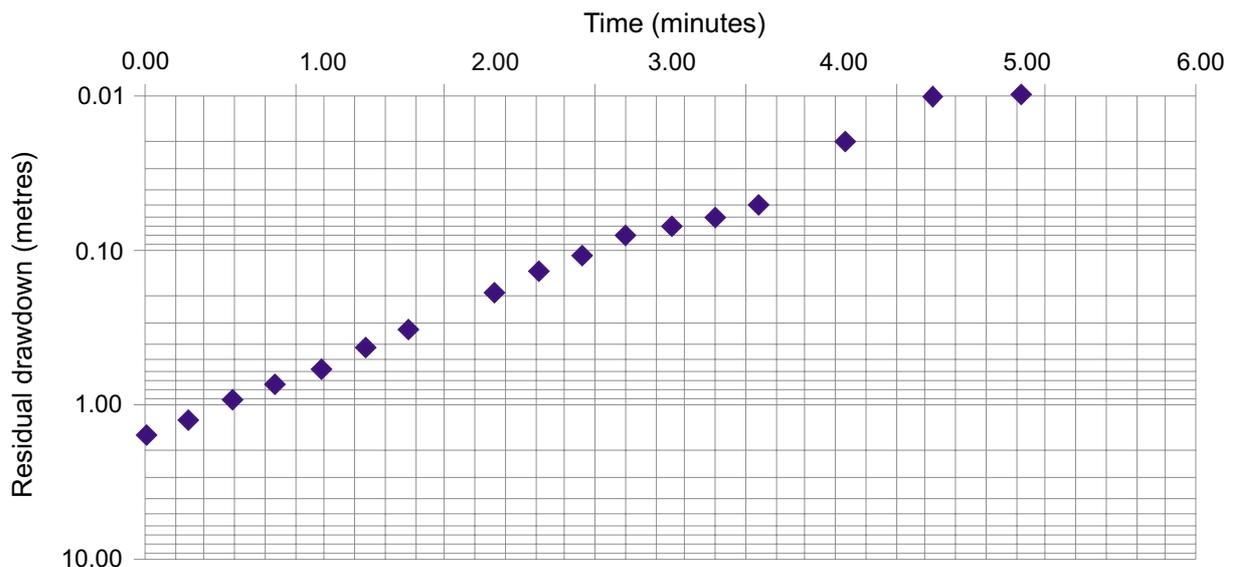
Recovery SSL 2000/2, 14 August 2001

Stanley lagoons recovery pump test – Slug extraction recovery data

Date: 14/08/2001
Bore: SSL 2000/2
TD: 2.50 m
Flow: 4.0 l/m
SWL: 0.92 m

Slug extraction tests were carried out on bores SSL2000/2 and SSL2000/3 on 14 August 2001 (Appendix 2). The slug extraction tests were completed (5 to 20 litres) and levels monitored for five minutes (time for 95% plus recovery). Test data were analysed in the software package *AquiferWin32* (Version 2.17, Environmental Simulations Inc.). The Bouwer and Rice (1976 Unconfined Aquifer) solution was used to calculate the hydraulic conductivities shown in Figure 6 (a) and (b) for SSL2000/2 and SSL2000/3 respectively. This method was selected as the most appropriate available within the software package.

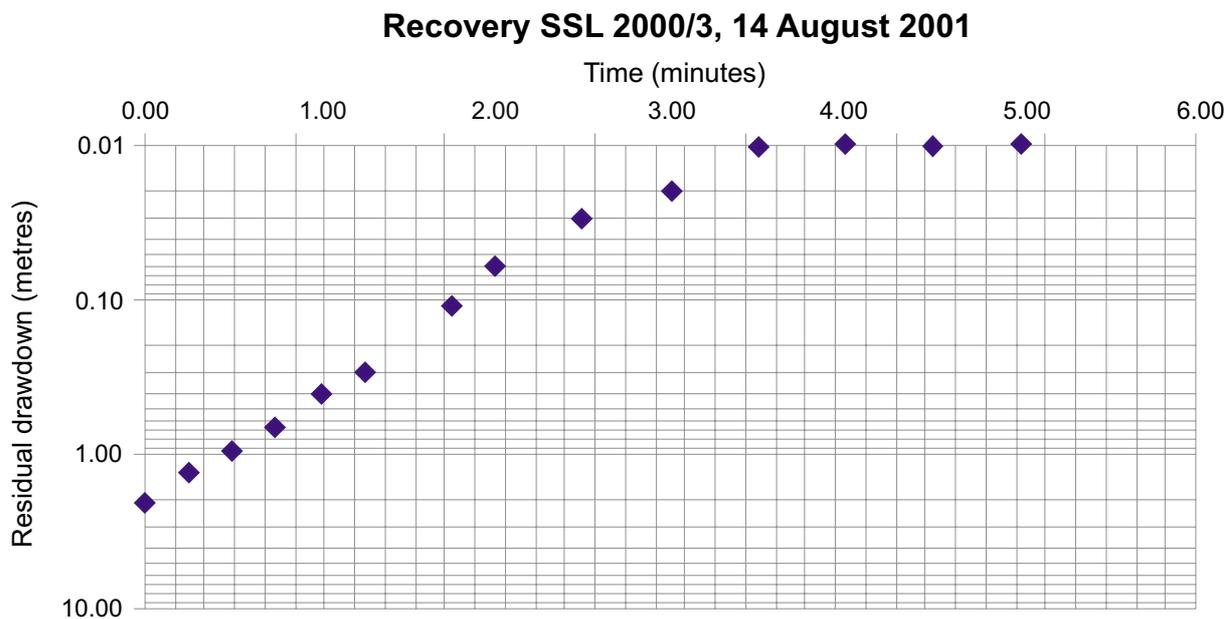
Stanley lagoons recovery pump test – Slug extraction recovery data

Date: 14/08/2001
 Bore: SSL 2000/3
 TD: 3.50 m
 Flow: 1.0 l/m
 SWL: 1.44 m

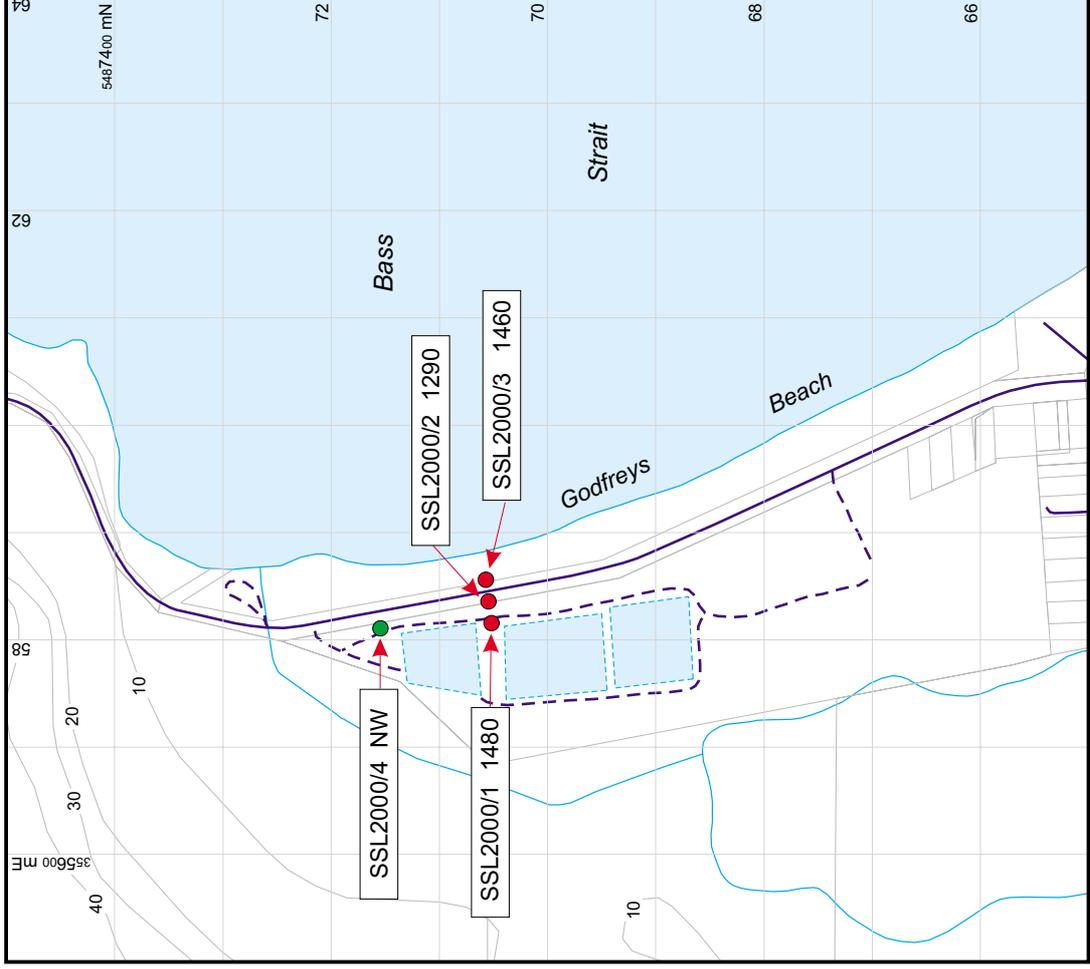
**Stanley Sewage Lagoons
November 2000
Conductivity ($\mu\text{S}/\text{cm}$)**

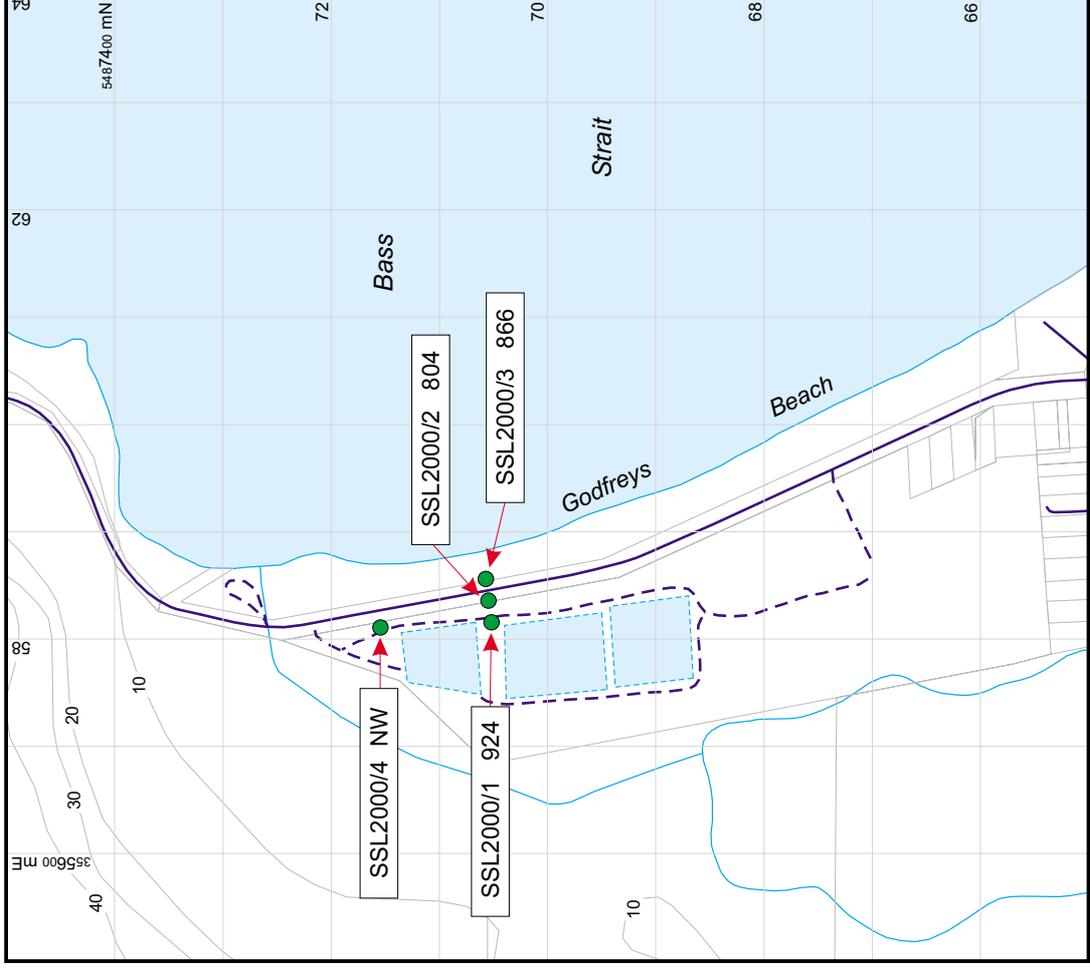
**Stanley Sewage Lagoons
November 2000
TDS (mg/L)**

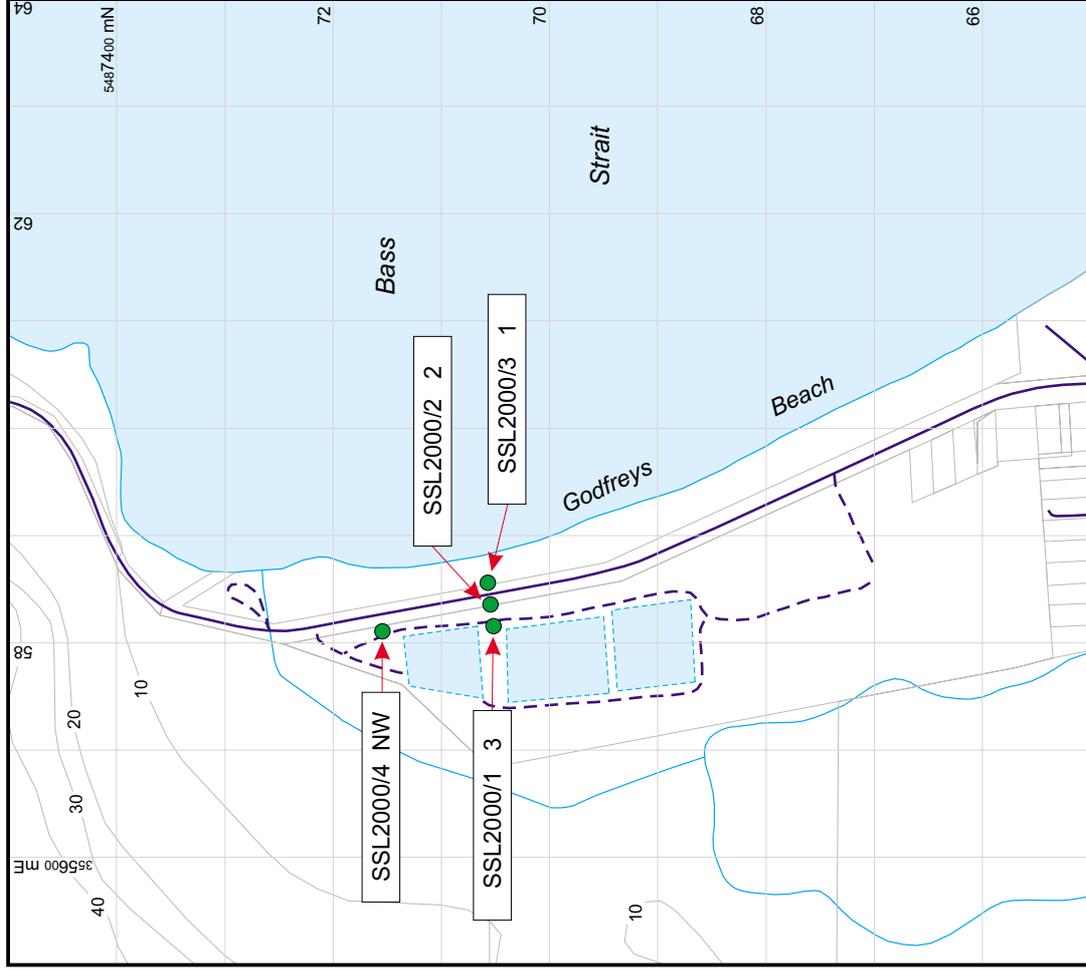
Stanley Sewage Lagoons
November 2000
Alkalinity CO₃ (mg/L CaCO₃)

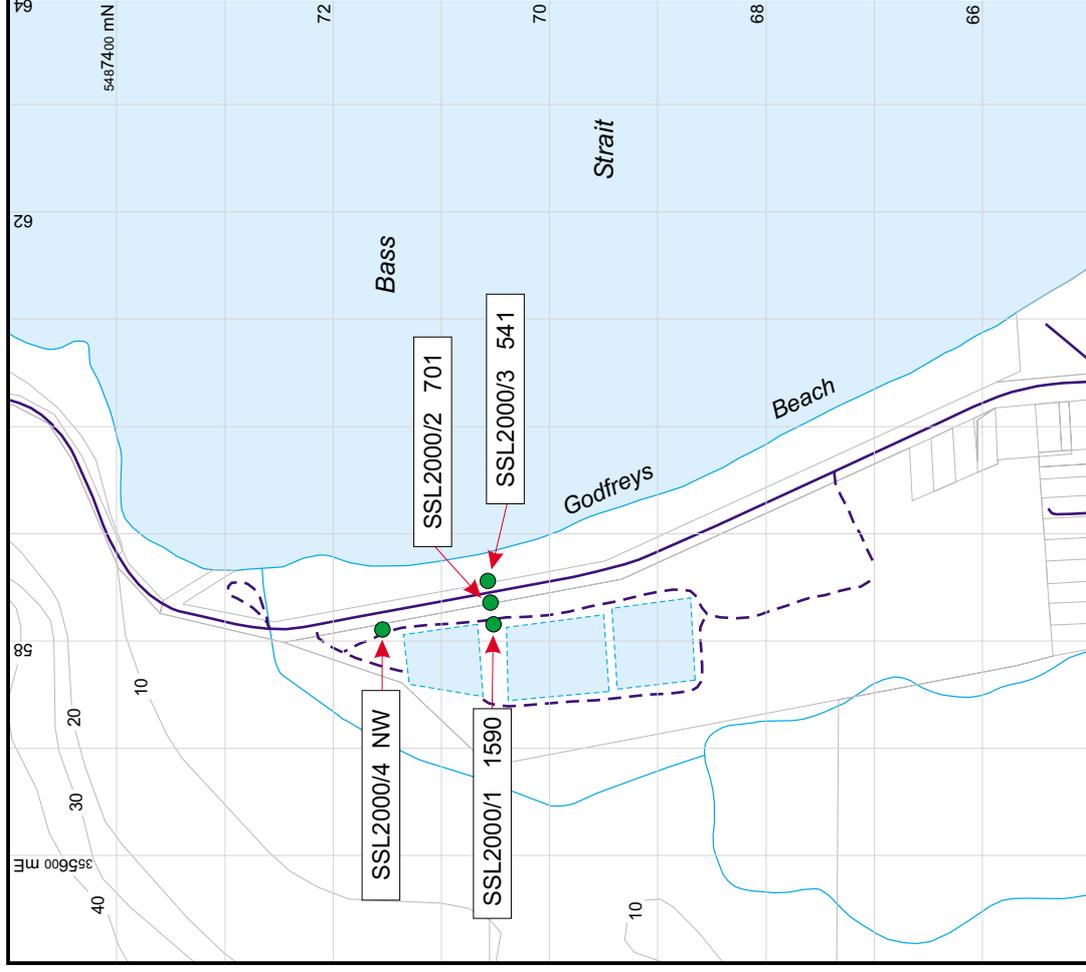
Stanley Sewage Lagoons
November 2000
Alkalinity HCO₃ (mg/L CaCO₃)

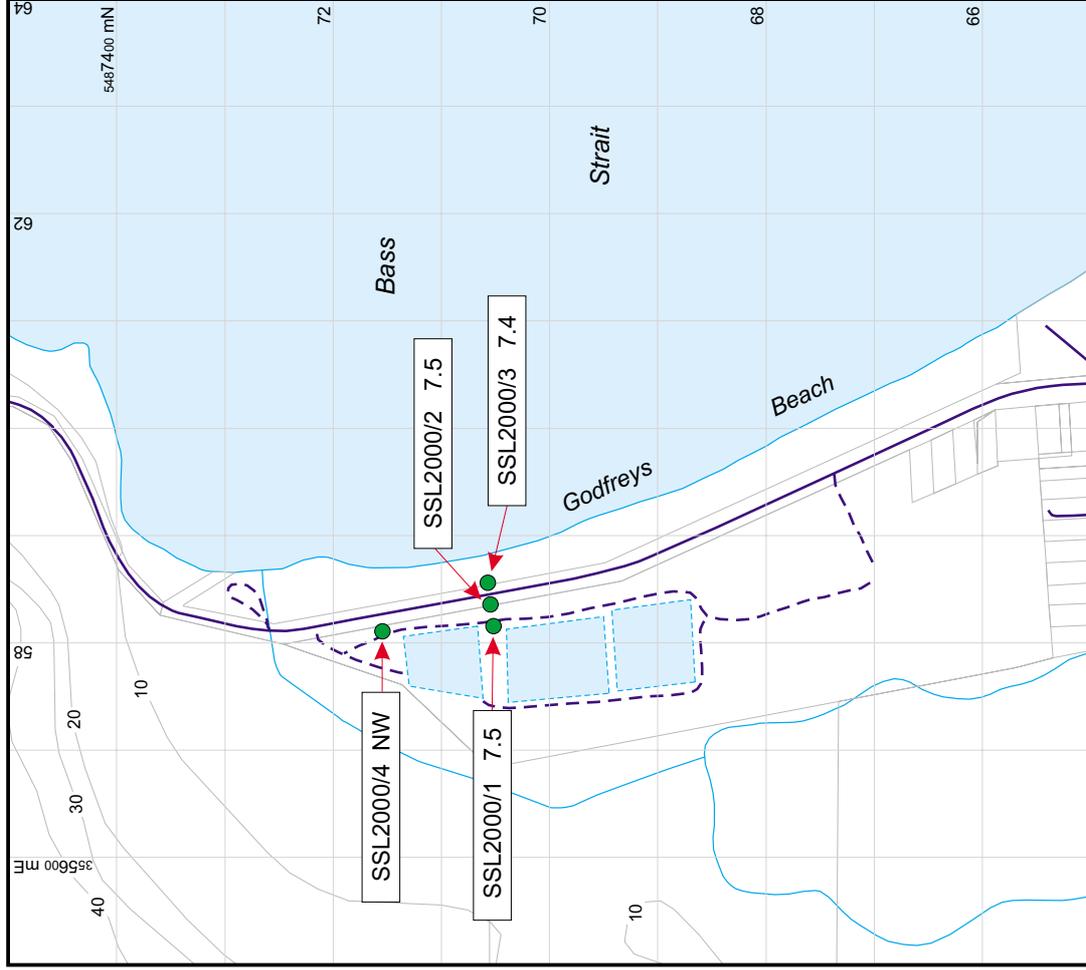
**Stanley Sewage Lagoons
November 2000
pH**

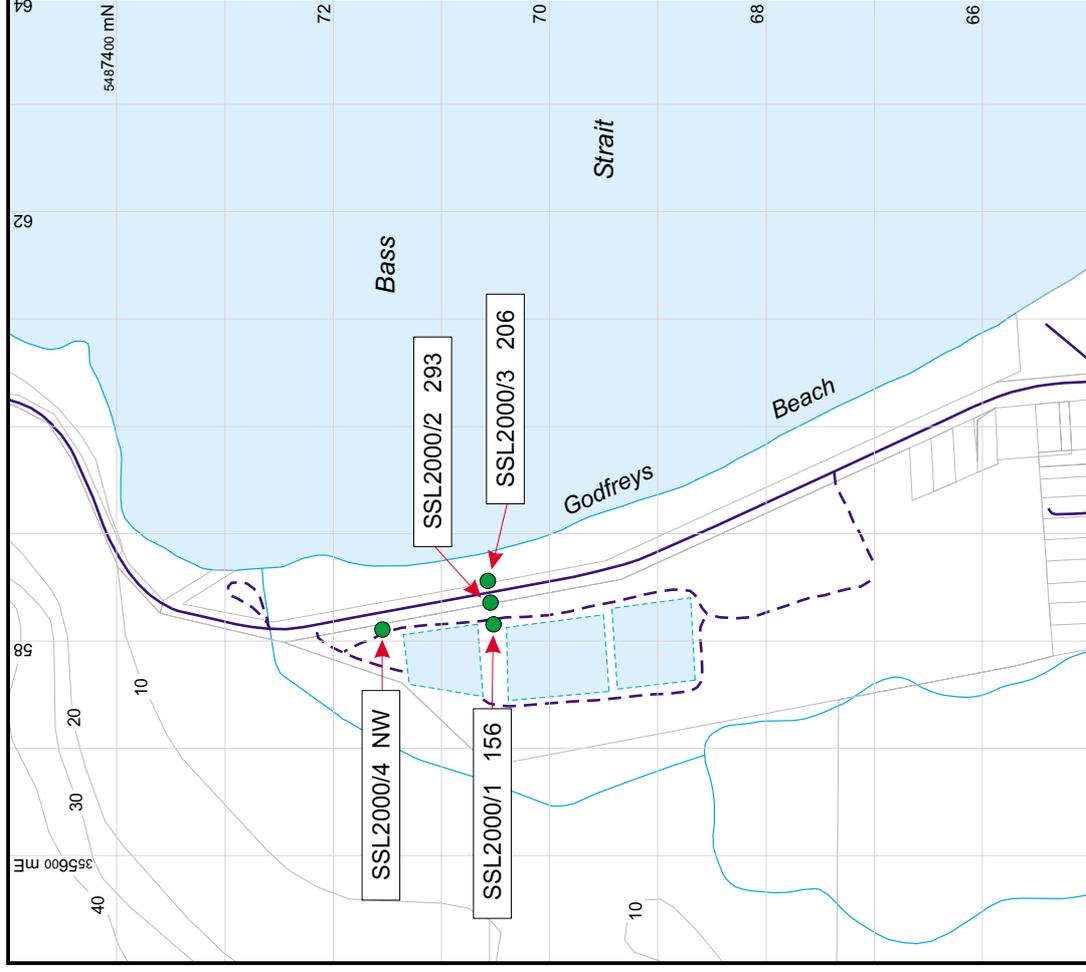
**Stanley Sewage Lagoons
November 2000
Ammonia ($\mu\text{g-N/L}$)**

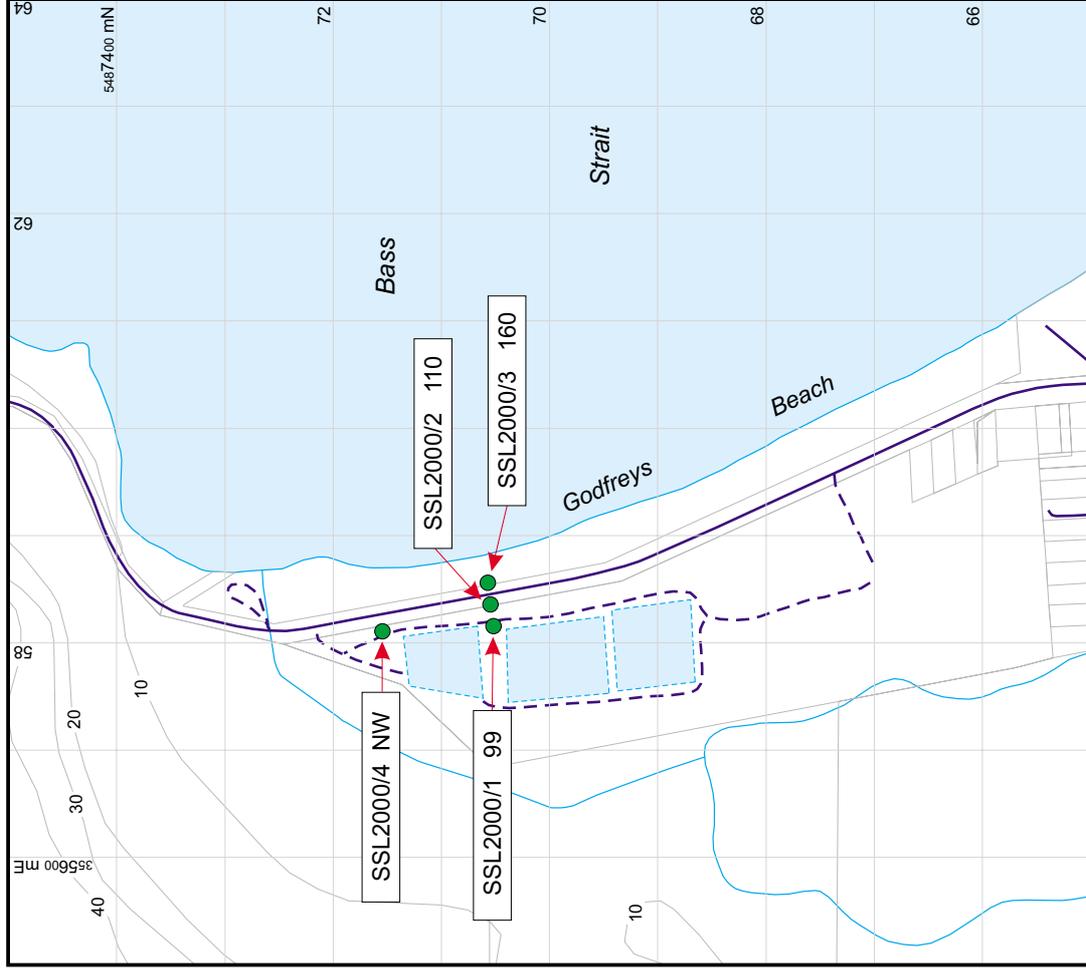
**Stanley Sewage Lagoons
November 2000
Chloride (mg/L)**

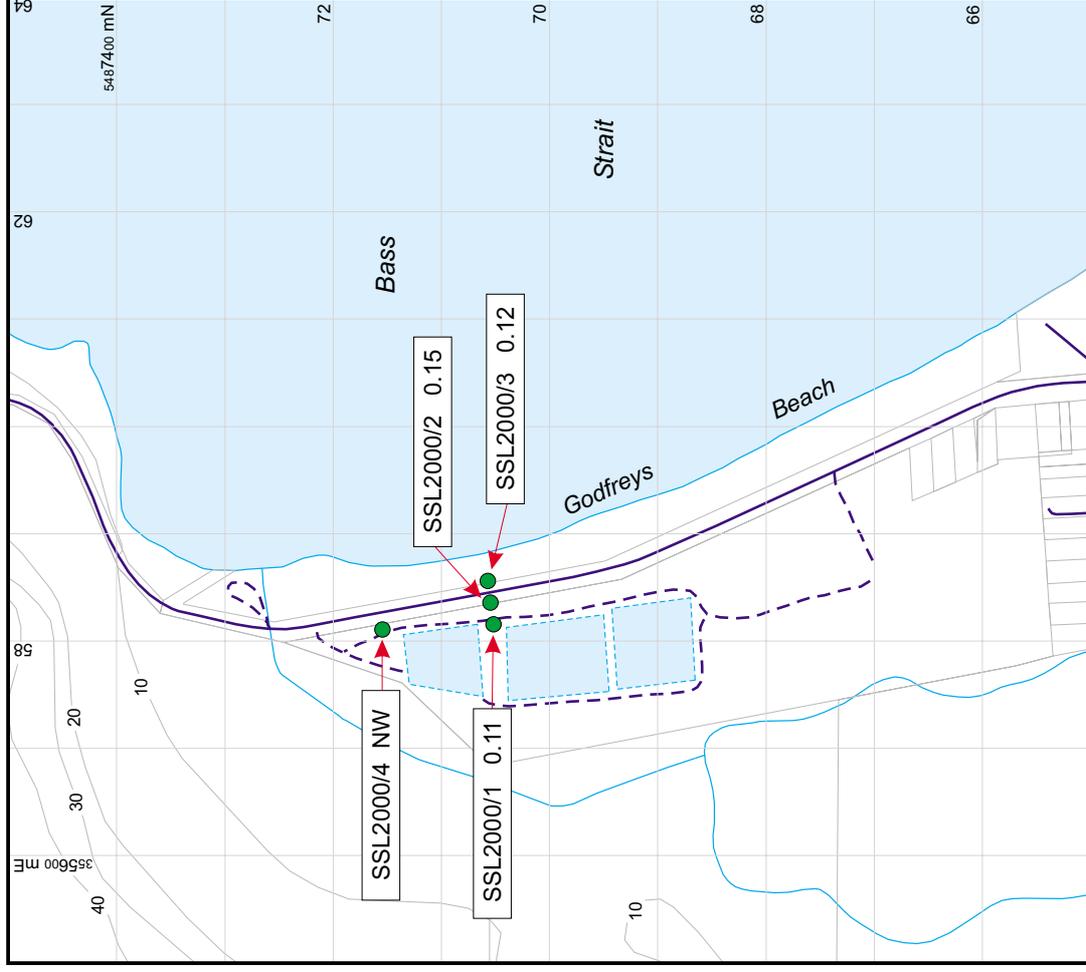
**Stanley Sewage Lagoons
November 2000
Fluoride (mg/L)**

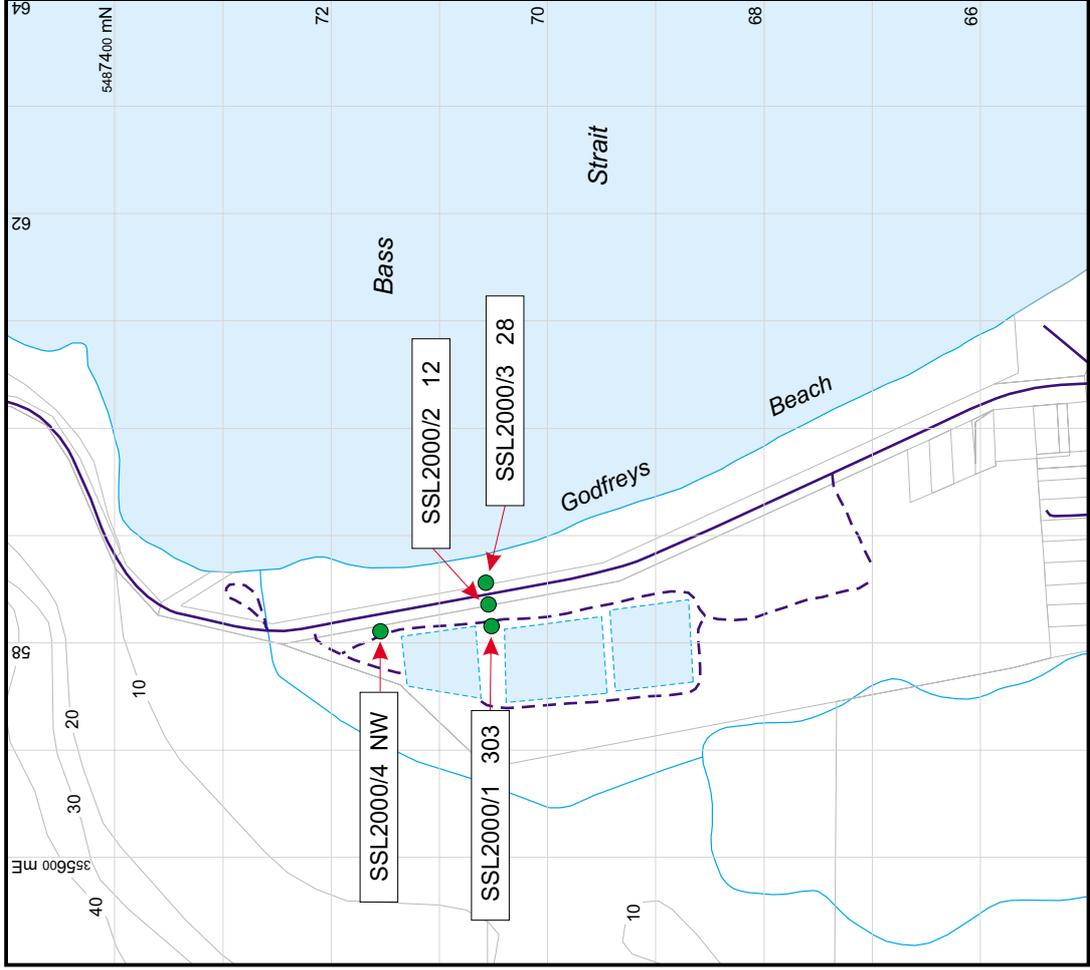
**Stanley Sewage Lagoons
November 2000
Nitrite ($\mu\text{g-N/L}$)**

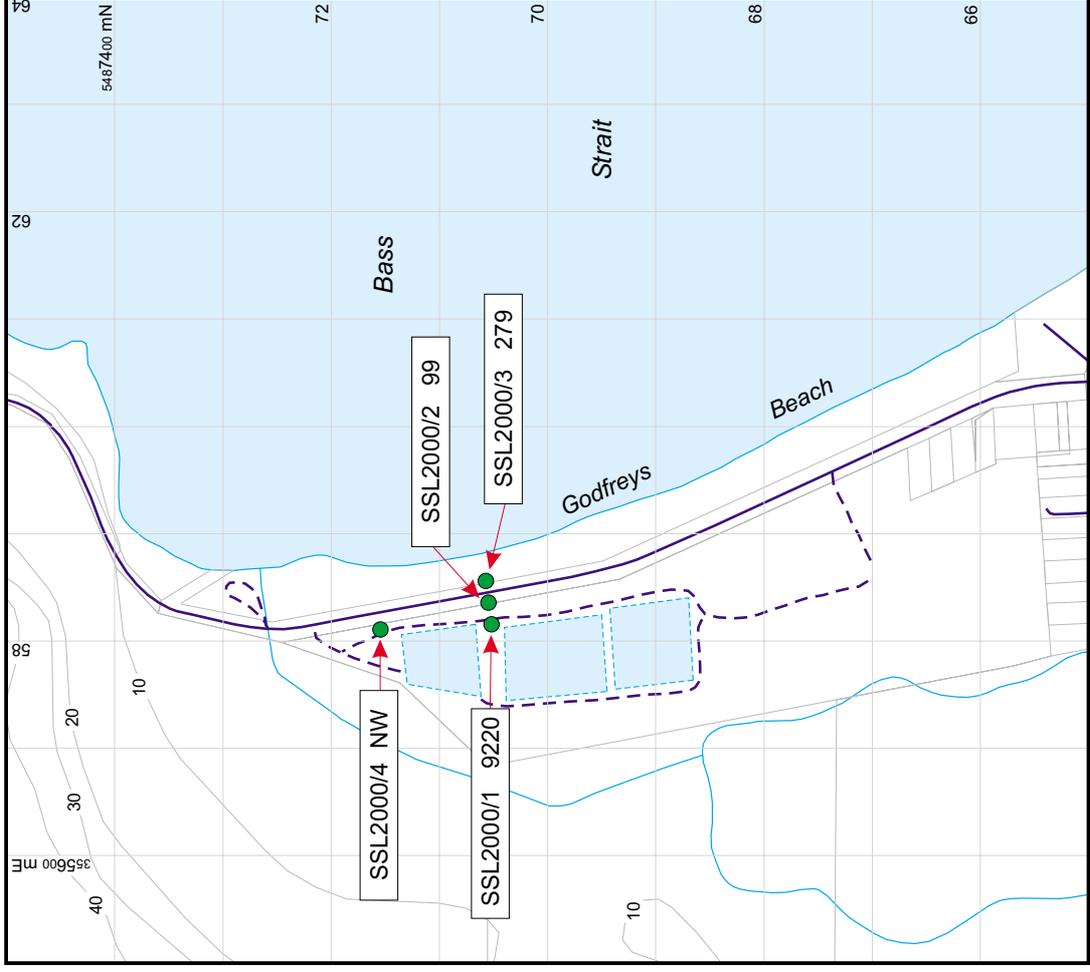
**Stanley Sewage Lagoons
November 2000
Nitrate + Nitrite ($\mu\text{g-N/L}$)**

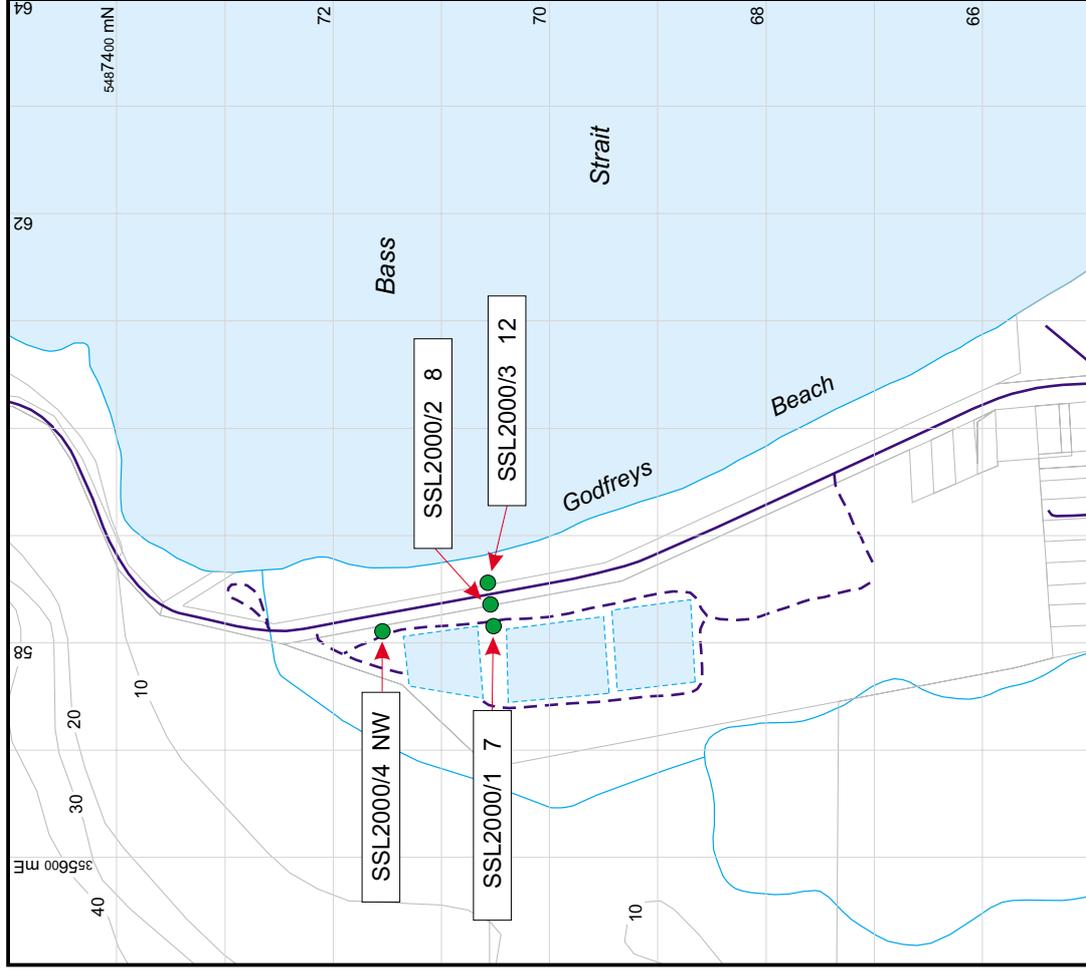
**Stanley Sewage Lagoons
November 2000
Ortho-P ($\mu\text{g-P/L}$)**

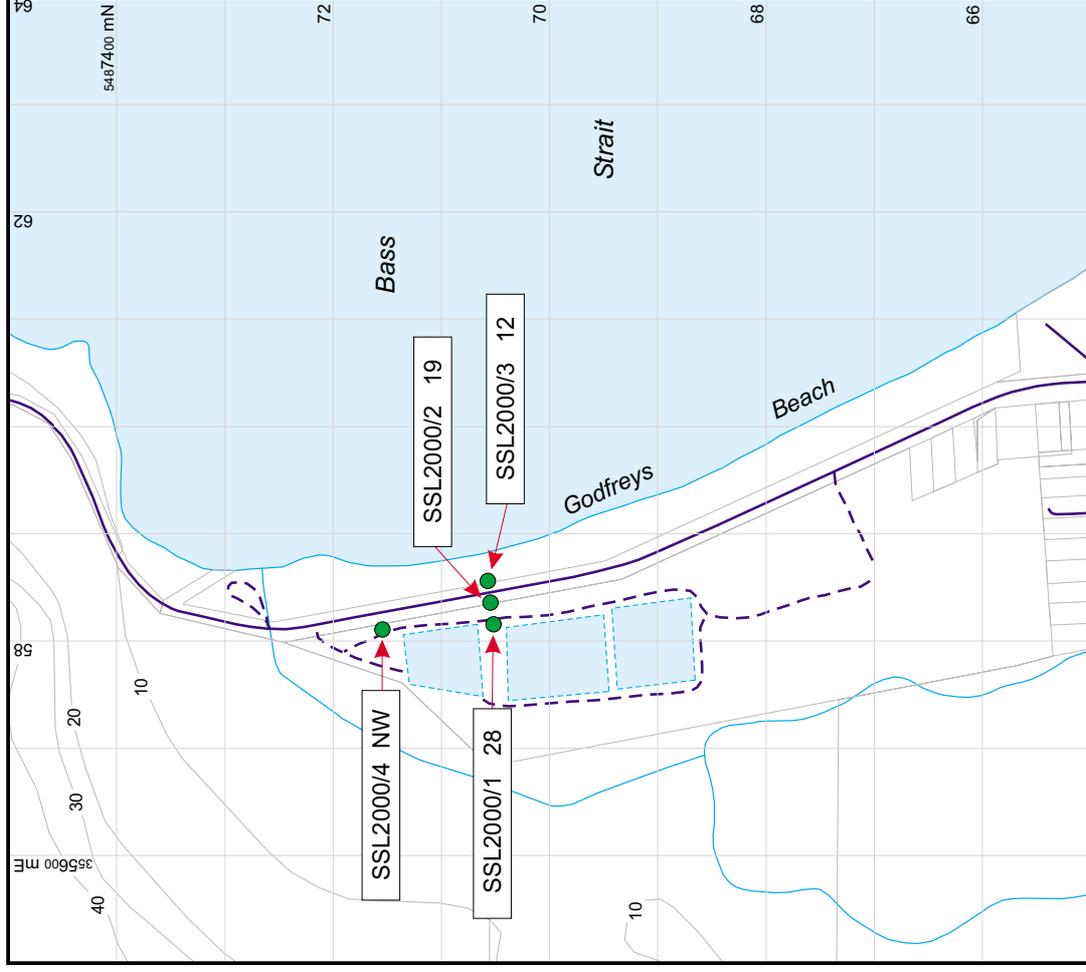
**Stanley Sewage Lagoons
November 2000
Sulphate (mg/L)**
