TAROONA LAND STABILITY INVESTIGATION

LANDSLIDE FEATURES AND SLOPE CLASSIFICATION

Figure 8

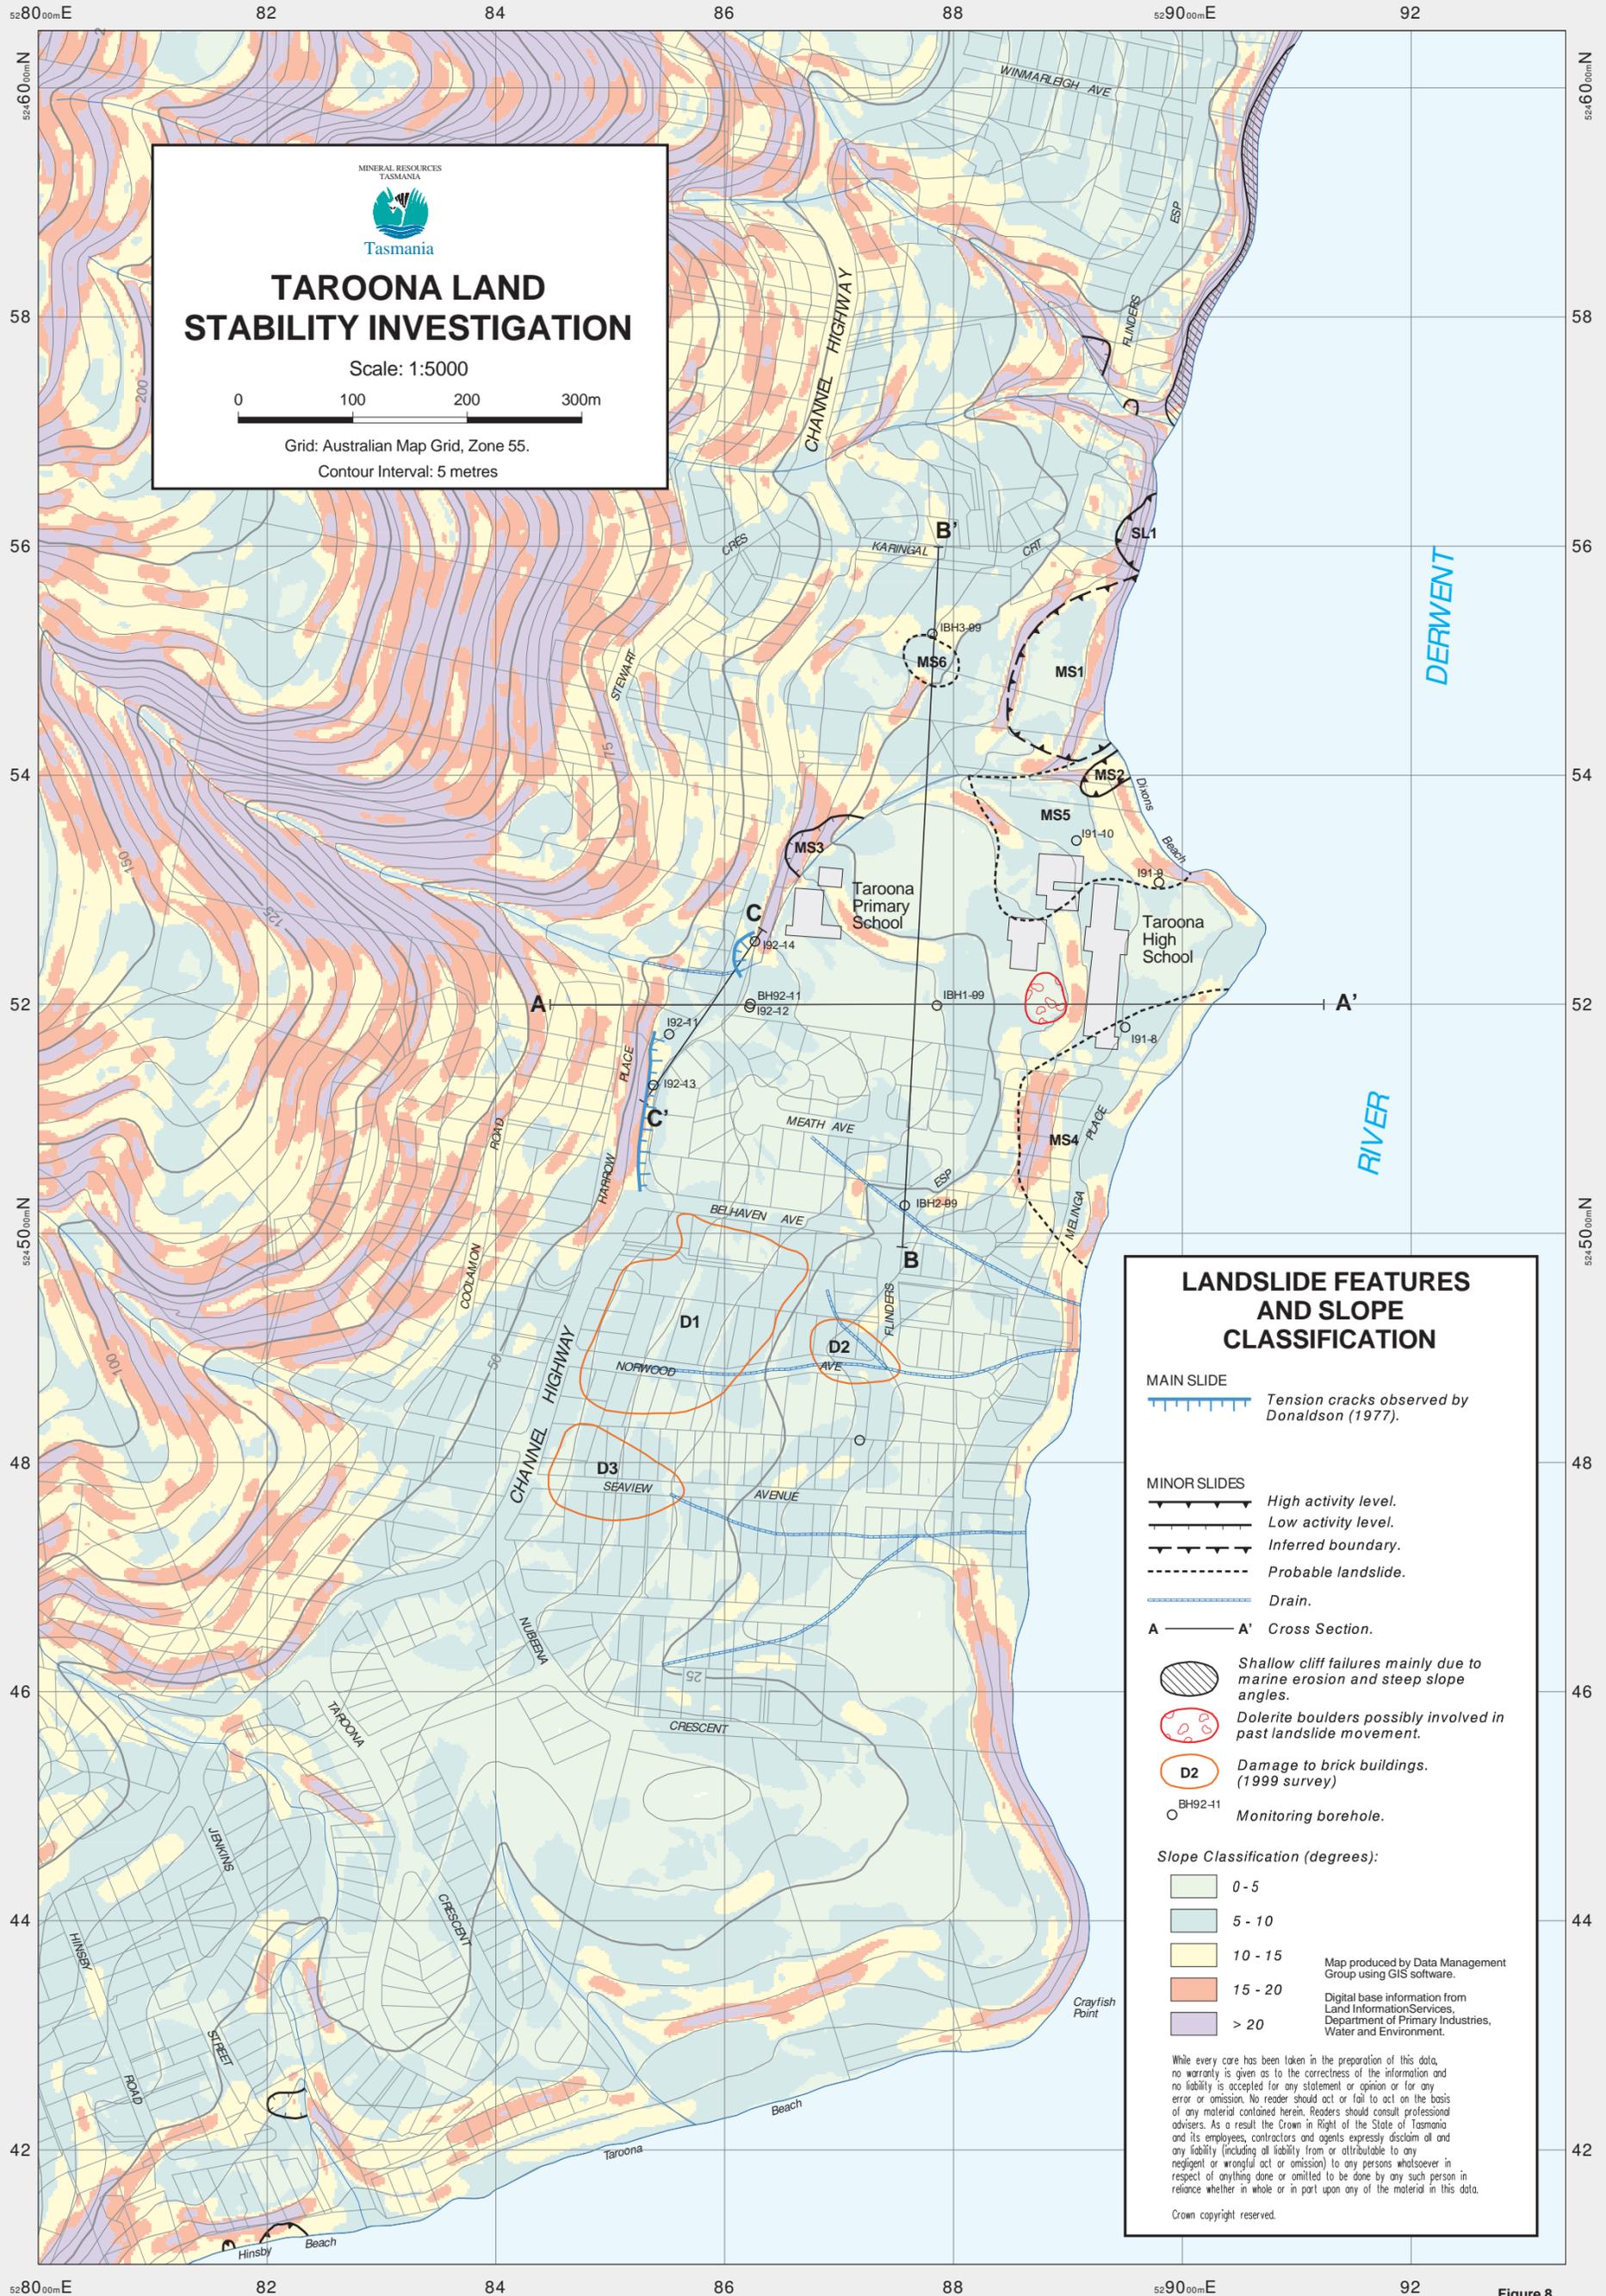
MAIN SLIDE
 Tension cracks observed by Donaldson (1977).

MINOR SLIDES
 High activity level.
 Low activity level.
 Inferred boundary.
 Probable landslide.
 Drain.

Shallow cliff failures mainly due to marine erosion and steep slope angles.
 Dolomite boulders possibly involved in past landslide movement.
 Damage to brick buildings. (1999 survey)
 Monitoring borehole.
