PARNELLA LANDSLIDE AREA - ST HELENS

GEOMORPHOLOGY AND LANDSLIDE MAP

Map 1A

M.D. Stevenson, 2013

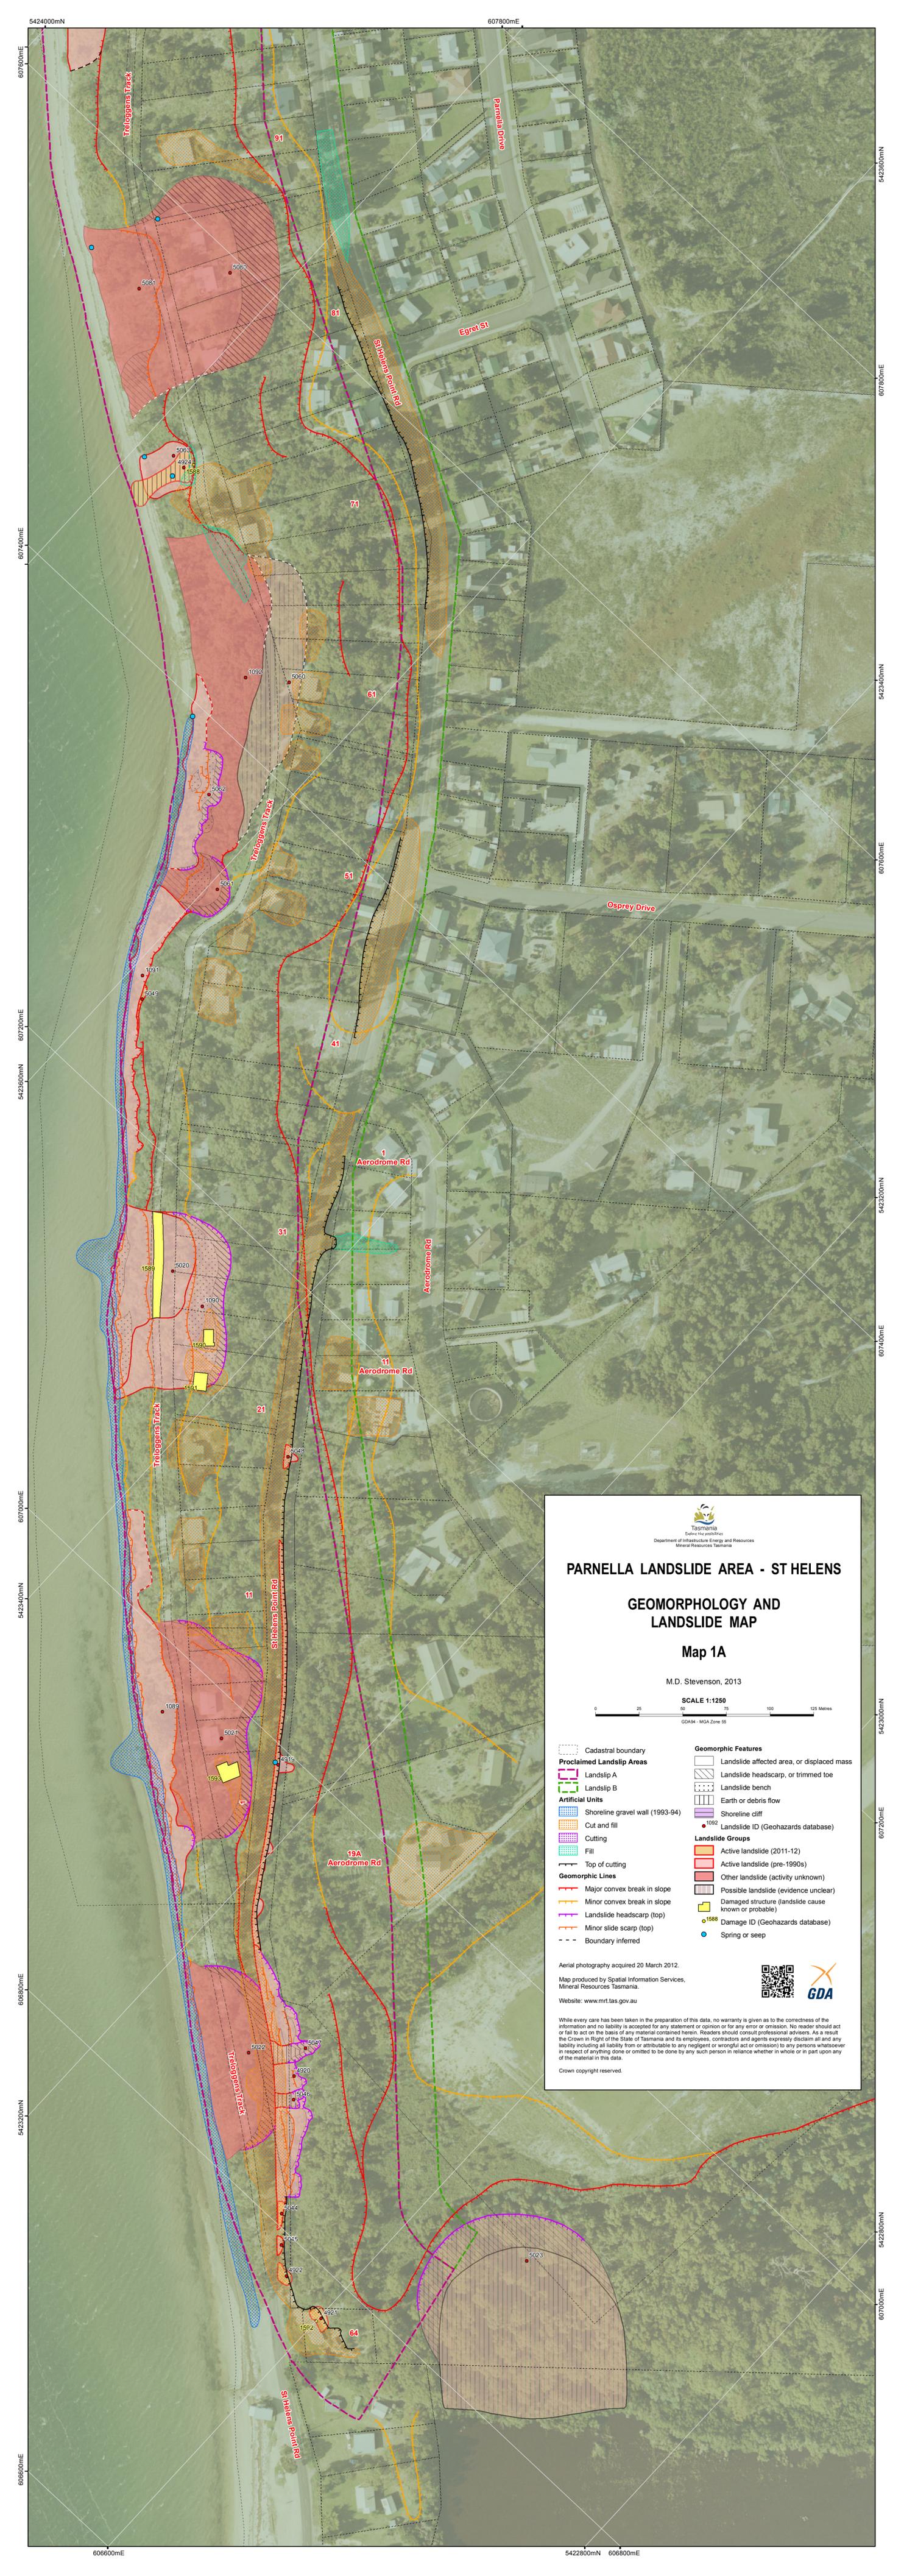
<ul style="list-style-type: none"> Cadastral boundary Proclaimed Landslip Areas Landslip A Landslip B Artificial Units Shoreline gravel wall (1993-94) Cut and fill Cutting Fill Top of cutting Geomorphic Lines Major convex break in slope Minor convex break in slope Landslide headscarp (top) Minor slide scarp (top) Boundary inferred 	<ul style="list-style-type: none"> Geomorphic Features Landslide affected area, or displaced mass Landslide headscarp, or trimmed toe Landslide bench Earth or debris flow Shoreline cliff Landslide ID (Geohazards database) Active landslide (2011-12) Active landslide (pre-1990s) Other landslide (activity unknown) Possible landslide (evidence unclear) Damaged structure (landslide cause known or probable) Damage ID (Geohazards database) Spring or seep
--	---
