# ESSO NARIMBA-1

**BASS BASIN**

**ENVIRONMENTAL INTERPRETATION**

**NARIMBA APPENDIX B**

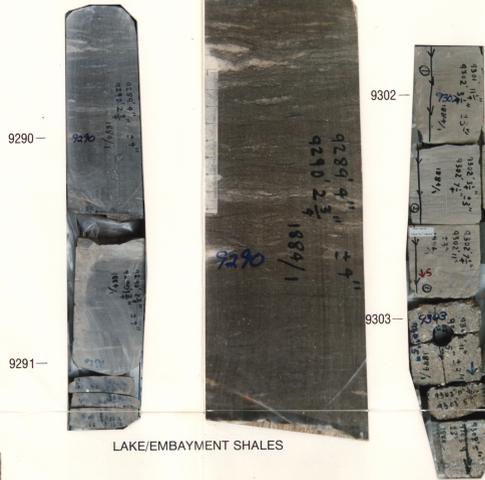
MARSH (BIOTURBATED/ROOTLETS)

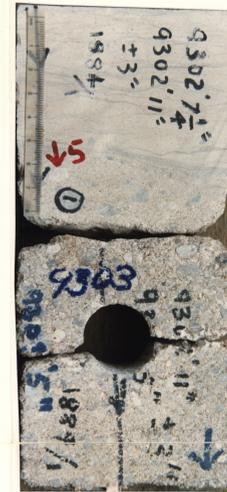
LAKE/EMBAYMENT SHALES

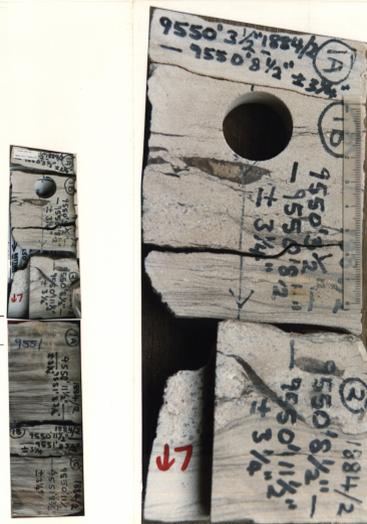
CHANNEL SANDS

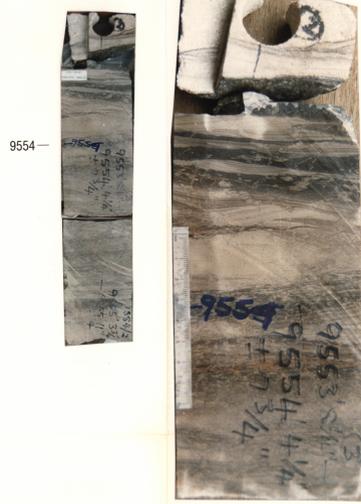
CREVASSE CHANNEL/ CREVASSE SPY

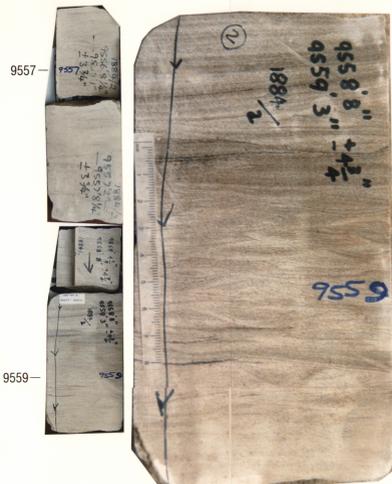
BIOTURBATED (CHONDRITES) LAKE/EMBAYMENT SHALES AND SANDS
