THE ELECTROLYTIC ZINC COMPANY OF AUSTRALASIA, LIMITED.  
West Coast Department.

S E C O N D Report.

THE MURCHISON MINE

December 1947

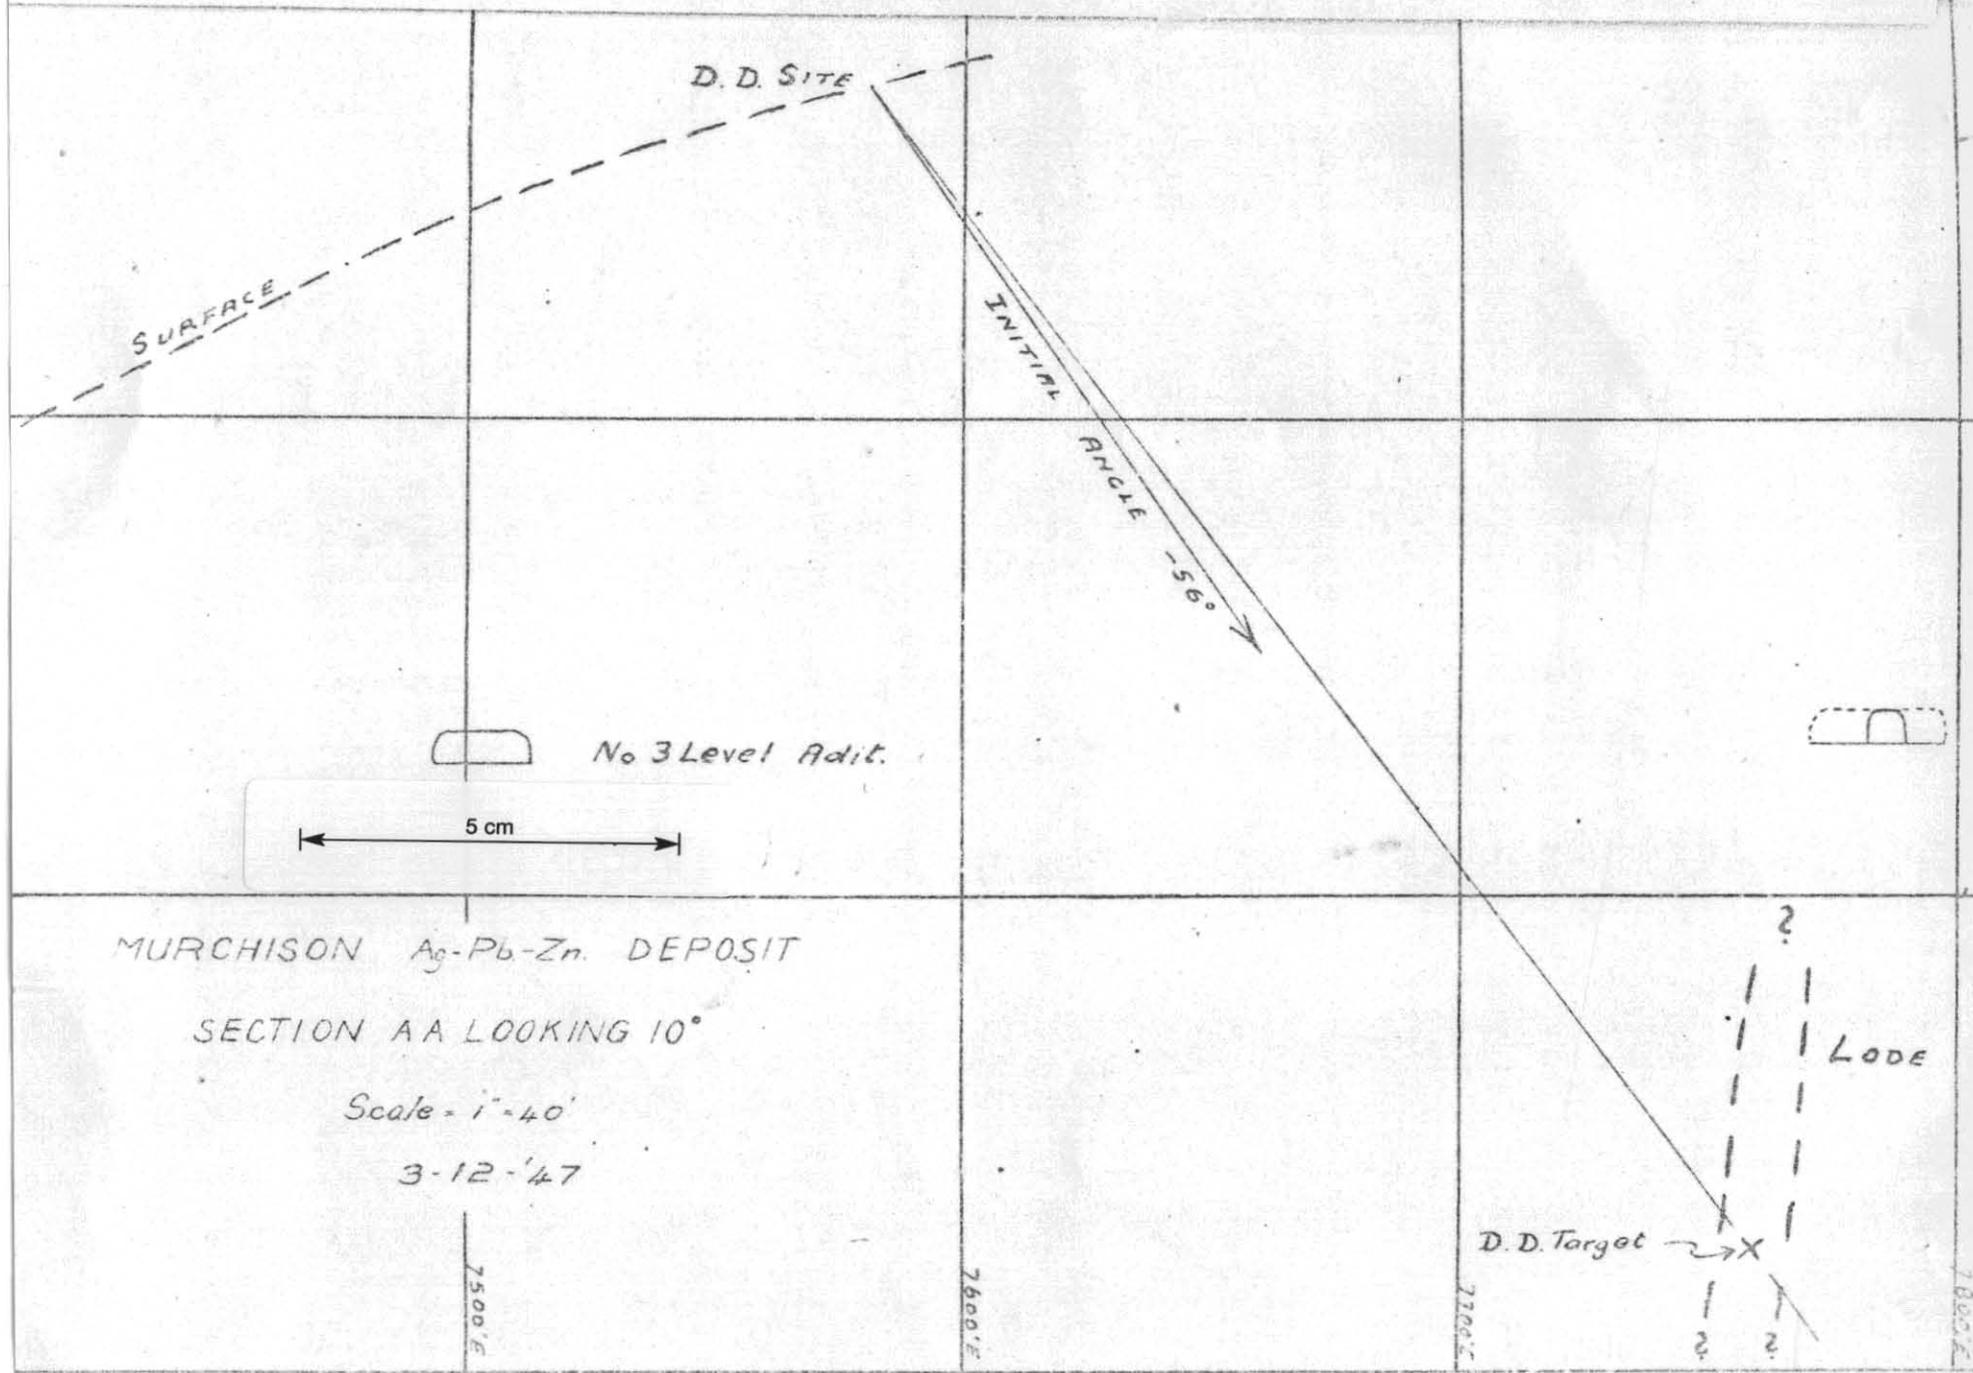
The target chosen for the first diamond Drill (MP2B) remains as shown in No. 4 Report of 10/47. The Plan and Cross-section herewith show the location of the drill site and the proposed angle of drilling. The Lode channel should be intersected at approximately 300' in the Drill hole.
