TASMANIAN CONSTRUCTION MATERIALS REGISTER

Serial No. 56 Grid Reference 24 6 398 Map Sheet No 82

Name of Owner/Quarry: T. Pearsall - Boronia Hill - Kingston

Sand Pits - Kingston Heights

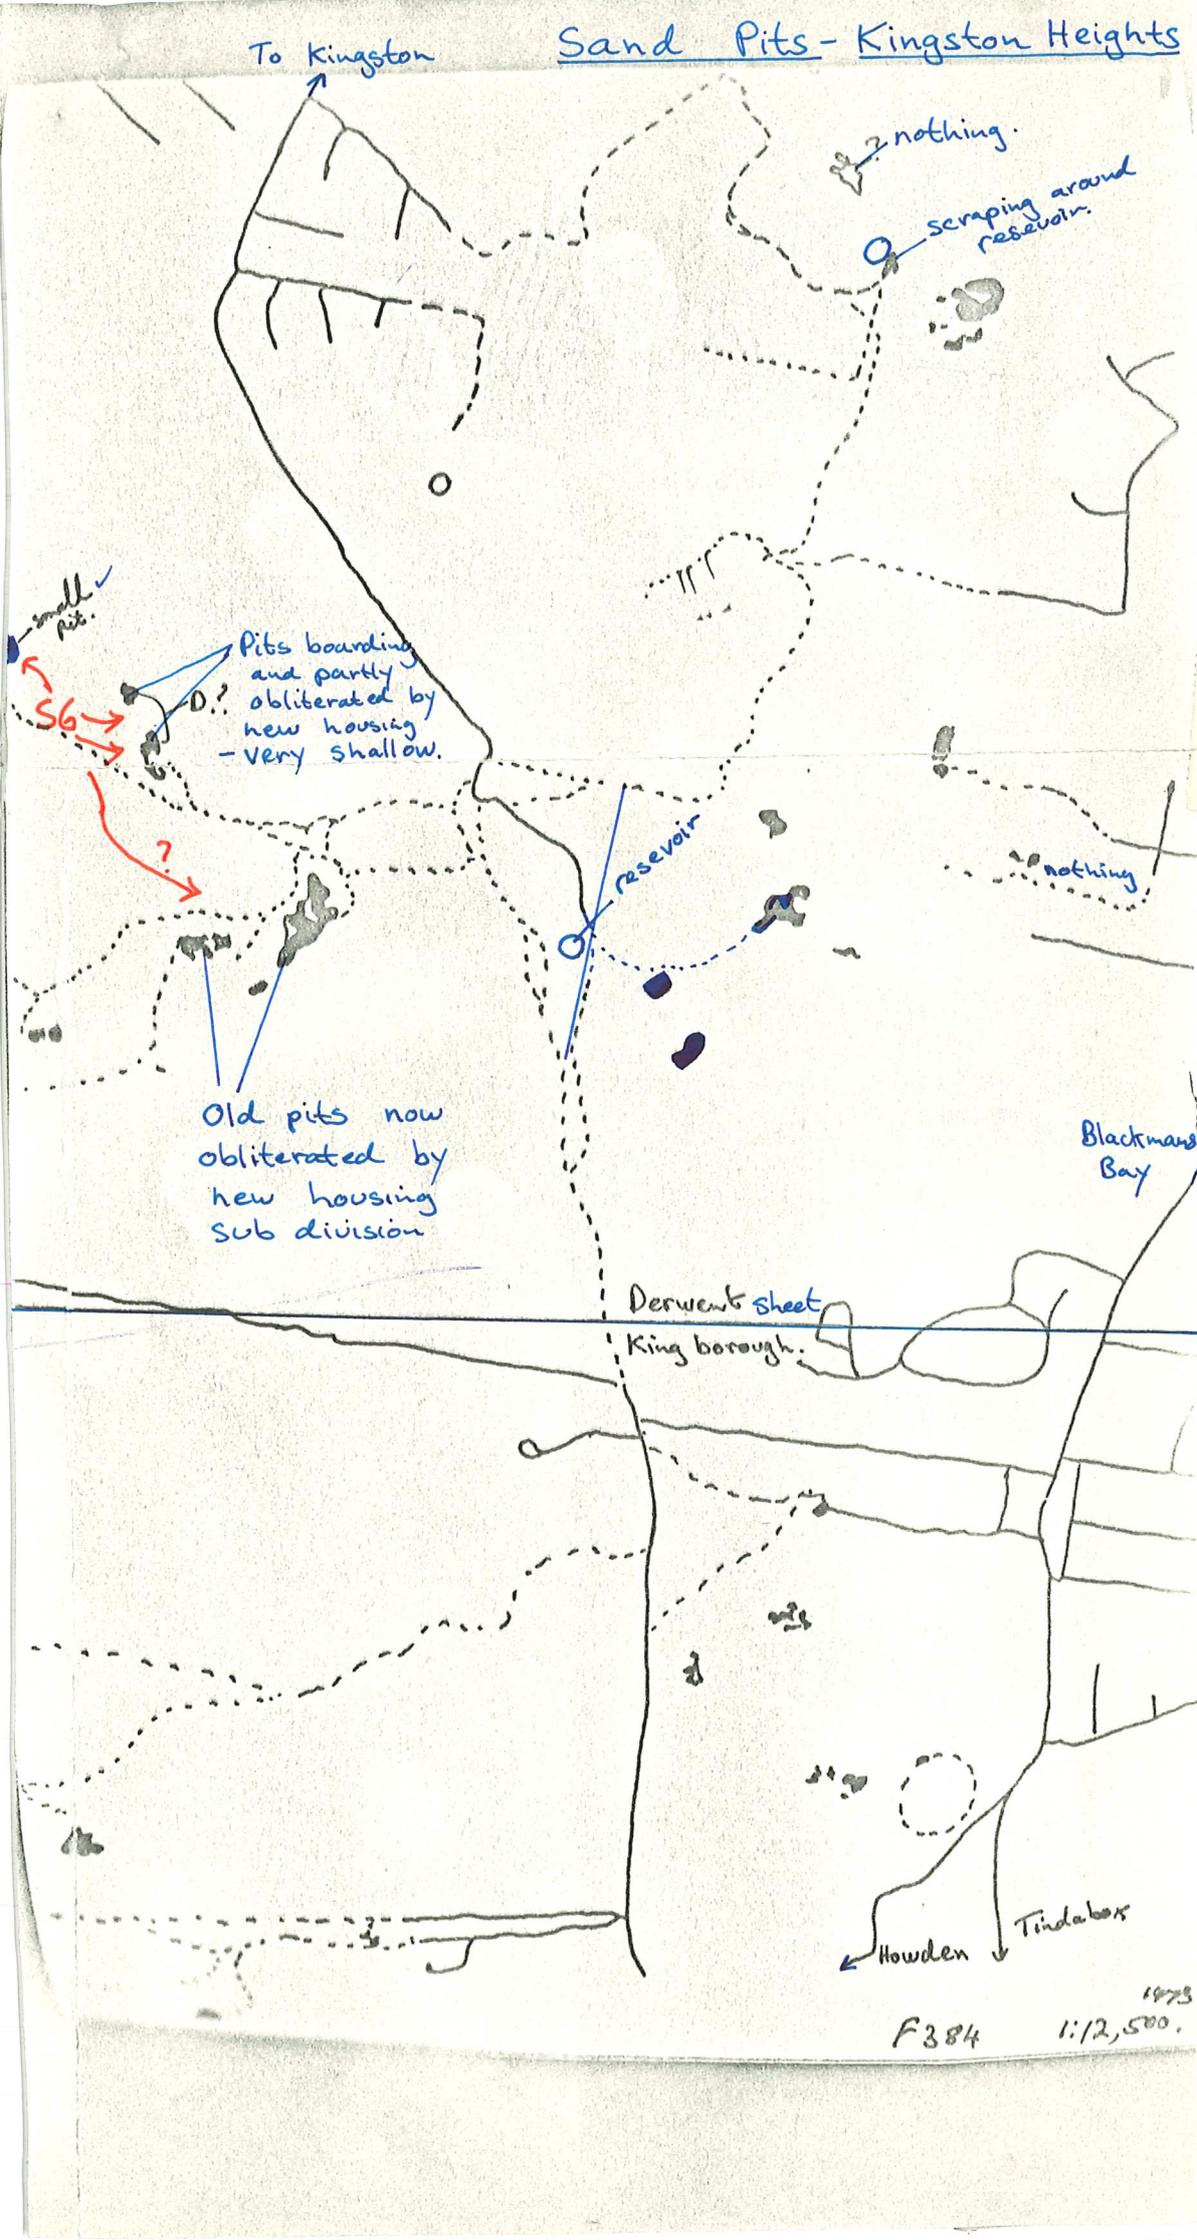
scraping around reservoir.

small pit.

Pits boarding and partly obliterated by new housing - very shallow.

Old pits now obliterated by new housing sub division
